Executive Summary: Bonney Lake Bicycle and Walking Audits

Prepared for the City of Bonney Lake by the Bicycle Alliance of Washington

February 2011

Emerald Hills Elementary School Walking Audit

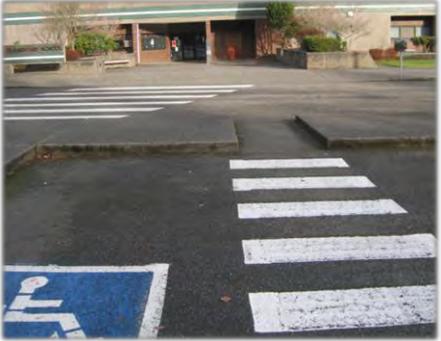
Item	Location	Description	Photo
<p>1</p> <p>☎</p> <p>📄</p>	<p>School parking lot</p>	<p>Crosswalks in school parking lot do not line up.</p> <p>Recommendation: Repaint the crosswalks so that they line up.</p>

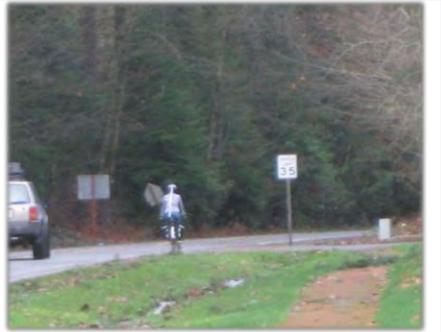
<p>2</p> <p>☎</p> <p>📄</p>	<p>On S Tapps Dr E, looking north</p>	<p>Sidewalk continues north along the school, then disappears at the point that the speed limit goes up to 35 mph. This makes walking along this stretch of S Tapps Dr E very dangerous, since it has no shoulder.</p> <p>Recommendation: Place a crosswalk either at the school's south or north driveways, along with a sidewalk or sufficiently wide gravel walkway on the west side of S Tapps Dr E. Ideally, a sidewalk would be placed on both sides of S Tapps Dr E north of this point, at least as far as Mayann Dr E.</p>

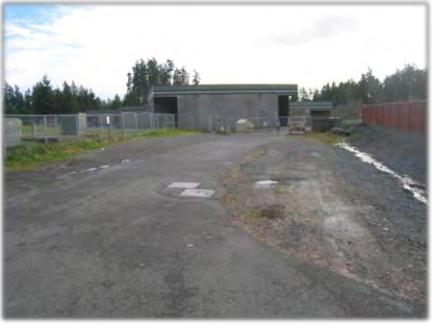
Item	Location	Description	Photo
<p>3</p>

<p>North pedestrian and bicyclist entrance, as seen from 192nd Ave E.</p>	<p>The school's north entrance from 192nd Ave E appears unfinished and uncared for. While this may not deter students from using this entrance, there is much that could be done to make this entrance more visually appealing, which could interest some students in walking who are currently driven.</p> <p>Recommendation: Involve students, teachers, and the community in envisioning a new look for this entrance, which could involve gardening, planting native species, an educational vegetable garden, a mural on the wall (which could depict students walking and biking to school) or whatever else is exciting to those involved in the envisioning process.</p>

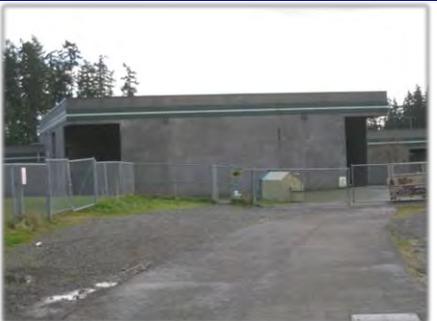
<p>4</p>

<p>A closer view of the north entrance</p>	<p>This closer view of the large blank wall greeting those using the north school entrance shows how much space there is to put a painting on the wall.</p> <p>Recommendation: Look to Mountain View Middle School as an example of an outdoor painting done several years ago by the students as part of an art project, in their case painted on surface pavement. At Emerald Hills the students could be involved with painting the lower portion, and with envisioning what could be painted higher up.</p>

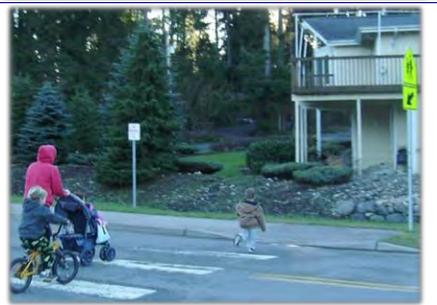
<p>Intersection of S Tapps Dr E and W Tapps Hwy E</p>	<p>This crosswalk is faded where vehicle tires pass over it.</p> <p>Recommendation: A repainting of the crosswalk should be mindful of automobile trajectory over it. A slight adjustment of the placement of individual hatch marks should prevent premature fading.</p>

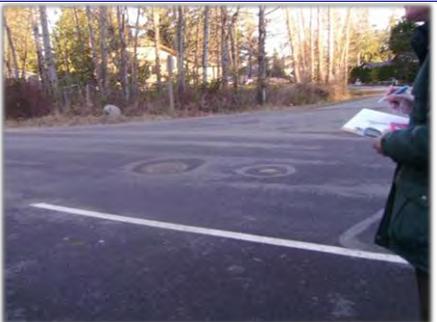
<p>Intersection of W Tapps Hwy E and 61st St E</p>	<p>Children likely travel across this intersection, but there is no visual indication to drivers to look for students or other pedestrians.</p> <p>Recommendation: Paint a crosswalk at this intersection, and place a school zone sign on W Tapps Hwy E to the east of this intersection.</p>

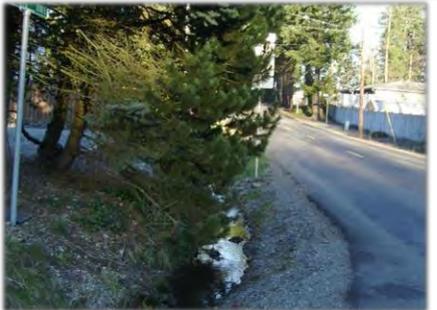
<p>Intersection of W Tapps Hwy E and 61st St E</p>	<p>There is a short, fairly sharp turn in W Tapps Hwy E right by the southwest pedestrian entrance to the school grounds. While not way out into the street, the tree shown here still hides students exiting the school grounds who may forget to look both ways.</p> <p>Recommendation: In addition to installing a crosswalk, it would be advisable to explain the situation to the resident on whose property this tree lives, and to ask them to cut back the branches. Alternately, if the branches are in the public right of way, it may be city's responsibility to trim back the branches.</p>

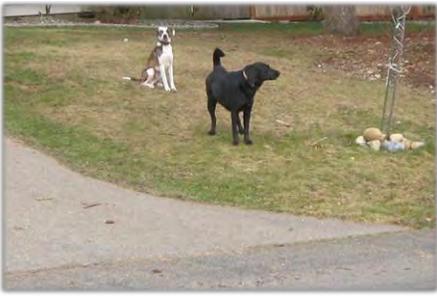
<p>At several locations around the neighborhood</p>	<p>Dogs off leash were observed in several locations in the neighborhood, often barking menacingly at us as we went by. This could frighten some children and deter them from walking, regardless of the actual degree of threat.</p> <p>Recommendation: Observe off-leash dogs in the neighborhood, and if threatening barking close to the street appears to be a common occurrence, consider explaining the situation to the dogs' owners and asking the owners to place their dogs on a leash, to erect a fence, or to keep the dogs in the back yard.</p>

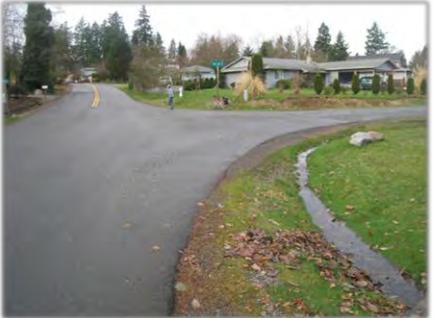
<p>Corner of 192nd Ave E and Maryann Drive E</p>	<p>Wide turning radii at intersections are fairly common. This enables drivers to make fast turns, endangering pedestrians who may be present, including but not limited to Emerald Hills students.</p> <p>Recommendation: Speeding drivers were not observed during the audit. If speeding were to become an issue at some point, tightening up intersection corners like this could be considered as a means to slow drivers down, at least at intersections, which is precisely where the most accidents occur.</p>

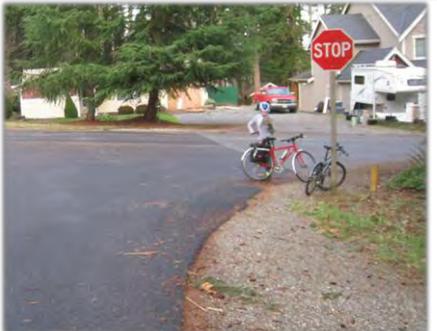
<p>10</p>

<p>Corner of 195th Ave E and 64th St E</p>	<p>This is another example of a large turning radius, a design feature that makes right-turning drivers less likely to come to a complete stop since it is so easy to roll through. Large turning radii also make right-turning drivers more likely not to see automobiles, bicyclists and pedestrians approaching from the left, as it requires a larger look over the shoulder rather than a mere glance to the left.</p> <p>Recommendation: Observe drivers at these intersections, and if insufficient slowing is occurring, consider tightening up the corners.</p>

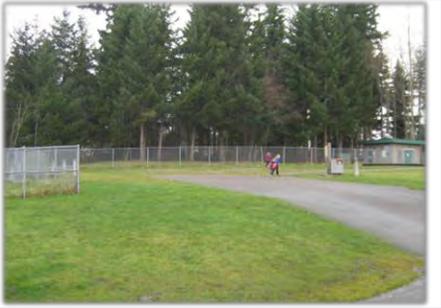
<p>Northeast quadrant of the school grounds</p>	<p>This forest to the north of the school's back field would provide fantastic access to 195th Ave E and beyond, a trip of at least .5 mi + currently. This trip could be cut back to about 500 to 195th Ave E, making walking to school far more attractive to students living to the east.</p> <p>Recommendation: If this land is owned by the school, then it should be considered an ideal location for a new trail with access straight to the school. This could be a dirt trail, or gravel or paved, and could connect either to 192nd Ave E or directly to the northeast corner of the school grounds.</p>

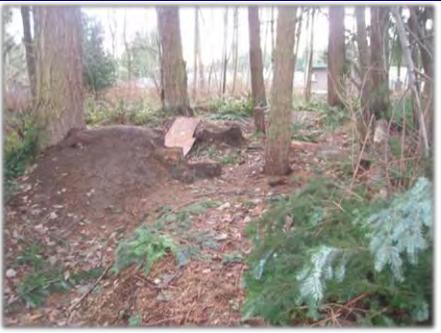
<p>Trail in forest just north of the school grounds</p>	<p>There is currently a trail into the forest in the picture above, but it appeared to only access a couple properties and an informal dirt bike play area.</p> <p>Recommendation: Place a formal trail through this forest connecting to 195th Ave E. It is possible and encouraged to leave the dirt bike play area intact so those kids using that area could continue to enjoy it.</p>

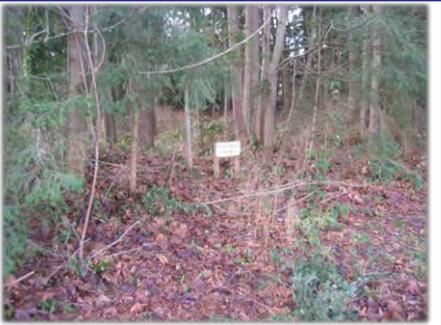
<p>13</p>

<p>On the west side of S Tapps Dr E, right across from the school</p>	<p>There is a sign reading "Private Property/ No Trespassing" directly across S Tapps Dr E from the school. Karen Harris, the school's safety patrol coordinator, remarked that kids used to cut through the forest to access 190th Ave Ct E, a move that cut a walk of .5 mi + down to 500 feet +. The sign was put in place nearly a decade ago and has been a significant deterrent to walking.</p> <p>Recommendation: Investigate the potential for an official trail through this area. The land is apparently slated for development at some point, but no specific development plans were known to the audit participants. The land owner may be receptive to coordination on a multi-use trail accessing 190th Ave Ct E. Painting of a crosswalk would go along with a new trail.</p>

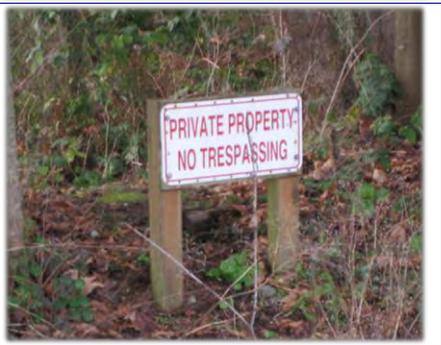
<p>On the west side of S Tapps Dr E, right across from the school</p>	<p>This is a close-up of the same sign shown above.</p>

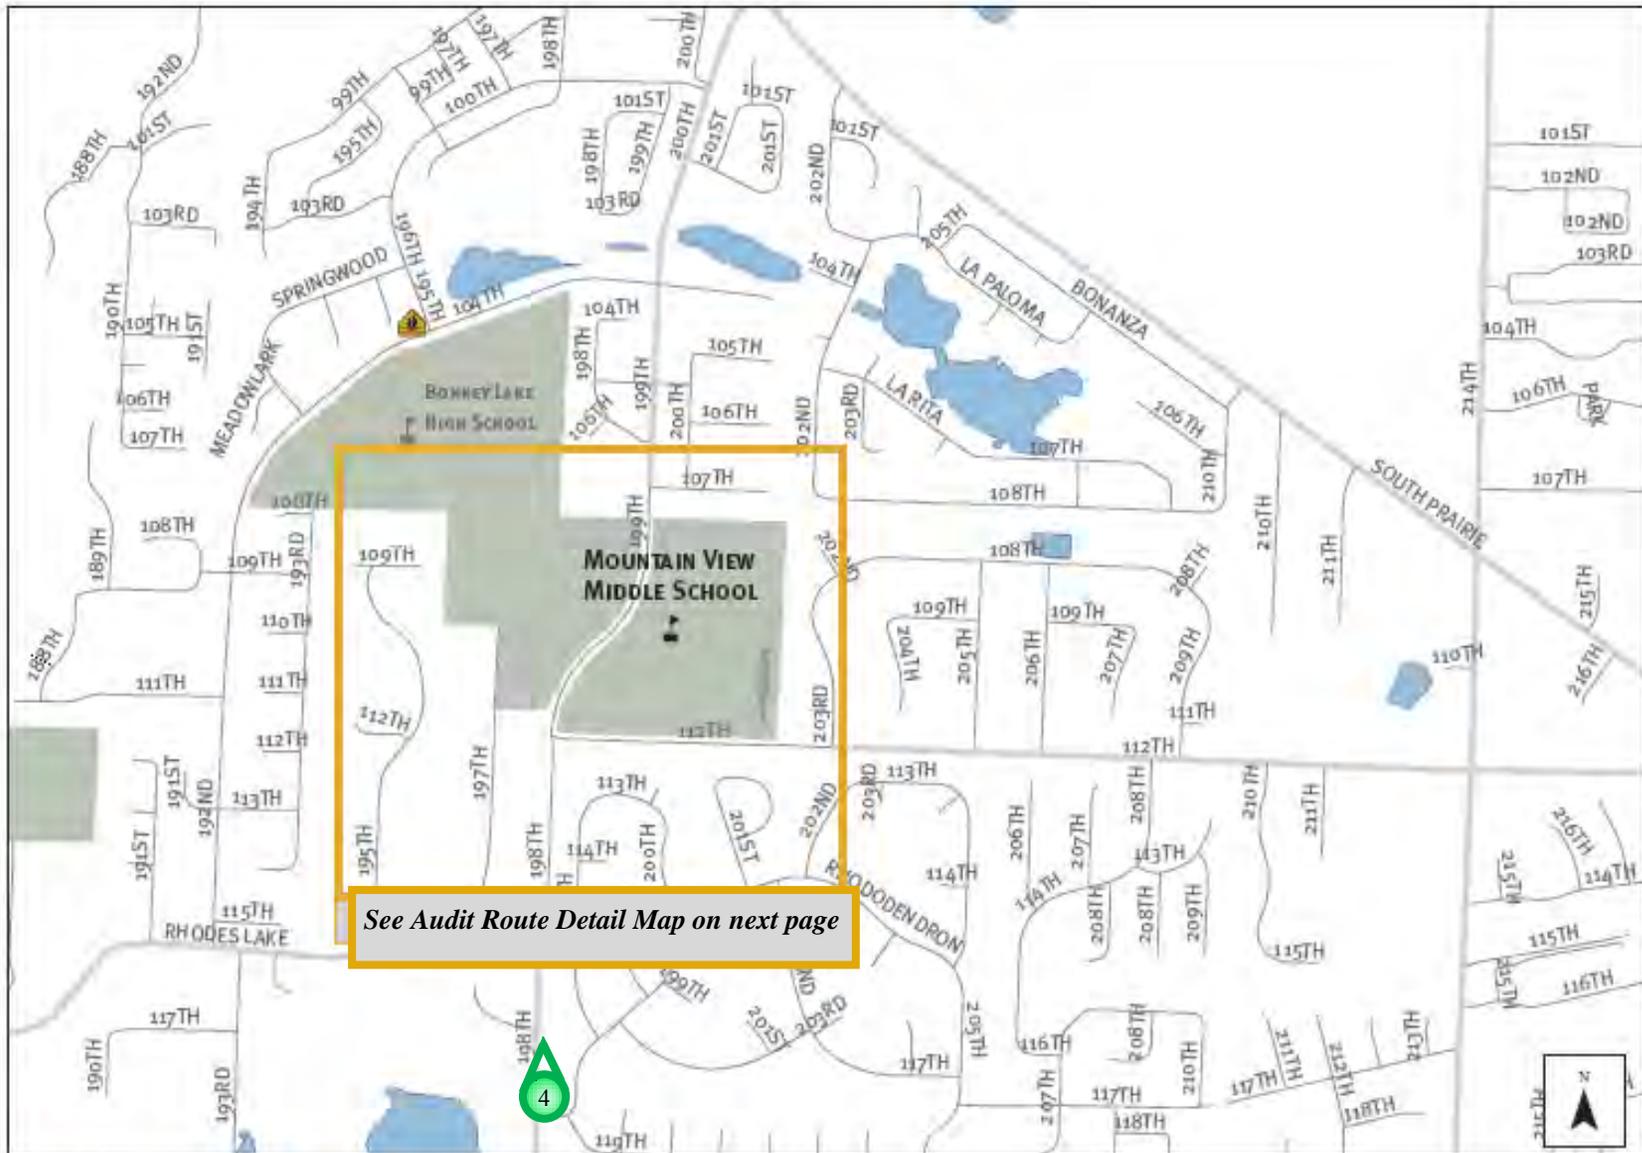
Mountain View Middle School Neighborhood Map, with photo numbers and perspectives

3 Photo Number and Perspective. Not shown are photos 2, 3, 6, 7, 8, 10, 11, and 13, as they were taken from nearly identical spots as other photos.

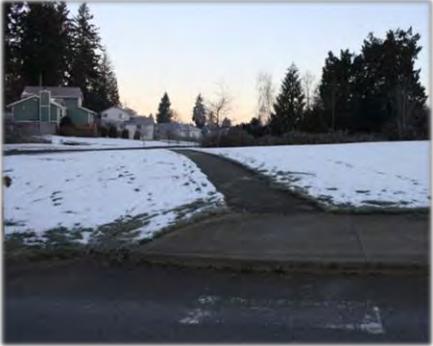
Item	Location	Description	Photo
<p>1</p>	<p>Near 199th Ave Ct E, along driveway leading to school's main entrance</p>	<p>Diagonal pathway from 199th Ave Ct E onto the school grounds is the most direct path from the street to the school grounds. The crosswalk is faded and students are encouraged to use another crosswalk about 40 ft to the west. Most students, due to encouragement from school staff and crossing patrol, are reportedly using the other crosswalk.</p> <p>Recommendation: If a time comes when more students resist using the other crosswalk, consider repainting this one and stationing crossing patrol at both crosswalks.</p>

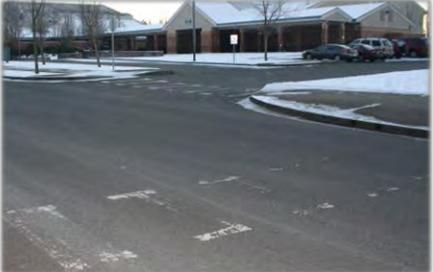
<p>2</p>	<p>Near 199th Ave Ct E, along driveway leading to school's main entrance</p>	<p>This is the same faded crosswalk discussed above, looking toward the school.</p>

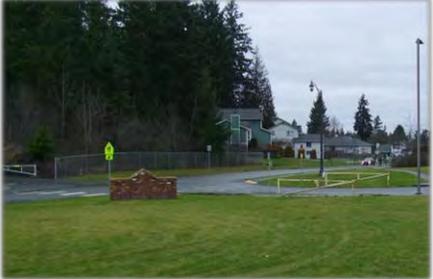
<p>3</p> <p>📄</p> <p>☎</p>	<p>Intersection of 199th Ave Ct E and the main driveway into the school parking lot</p>	<p>Audit participants mentioned that the intersection at the entrance to the school gets a lot of automobile traffic during drop-off and pick-up, and is insufficiently lit at the crosswalks to make more safe crossing conditions during winter mornings. Audit participants also recorded in their written observations that the crosswalk at 199th Ave Ct E and 104th St E is insufficiently lit. A student was hit by a car at that location.</p> <p>Recommendation: Install more lighting at these key intersections.</p>

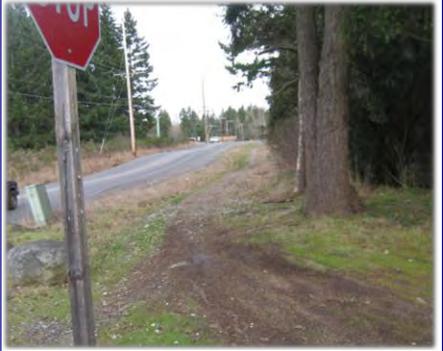
<p>Intersection of 198th Ave E and 199th St E</p>	<p>The area to the side of 198th Ave E appears to be used by pedestrians, ATVers and bicyclists. This path leads north along a dirt road straight to Mountain View Middle School. Much of the trail is in relatively poor condition, and is by no means an officially sanctioned route to school.</p> <p>Recommendation: Make this a gravel or paved community trail for pedestrians and bicyclists travelling between this area and the Mountain View Middle School neighborhood.</p>

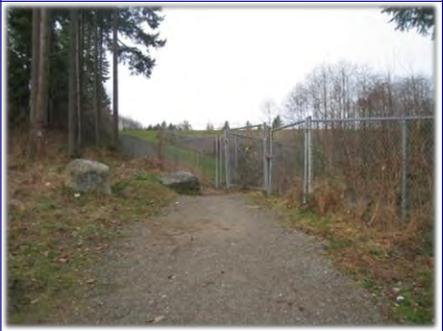
<p>5</p>

<p>Southeast entrance to school grounds, at the western end of 112th St E.</p>	<p>The southeast entrance to the school grounds is not labeled as such, and provides no other visual indication that this is a place where middle school students are welcome. In addition, audit participants mentioned that this entrance is very poorly lit during the winter early morning walks to school.</p> <p>Recommendation: Provide signage designating this as an official entrance to school grounds. Establish “ownership” of the area among middle school students by involving them in art projects to be installed at this entrance. In addition, add lighting here and along the trail leading to the school.</p>

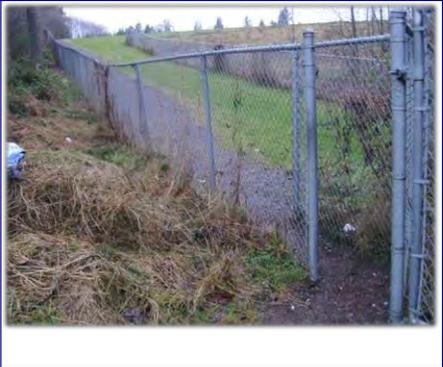
<p>6</p>

<p>Southeast entrance to school grounds, at the western end of 112th St E.</p>	<p>This entrance is narrow and confined, creating a sense that one could be trapped there if cornered by bullies. The rock next to it has spray-painted graffiti on it, is known among the students as “make-out rock,” and is also a place where a student on the audit reported observing people taking drugs.</p> <p>Recommendation: Reposition the chain link fence to create a less confining gateway experience. Work with middle school students to get ideas and create projects that would establish a sense of ownership for this school entryway among middle school students, which could include art, landscaping, carpentry or similar types of projects. Consider involving the students in painting the rock in an appealing, creative way.</p>

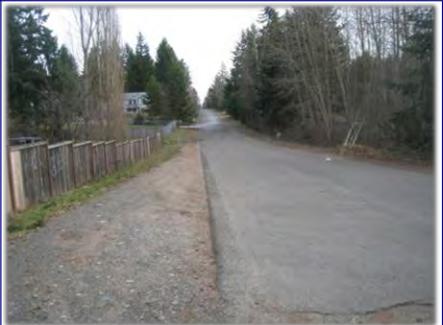
<p>7</p>

<p>Southeast entrance to school grounds, at the western end of 112th St E.</p>	<p>Looking east down 112th St E, an area reportedly travelled frequently by both middle school students and high school students, one sees no signage alerting drivers to the presence of pedestrians.</p> <p>Recommendation: Place one or more pedestrian signs along this approach.</p>

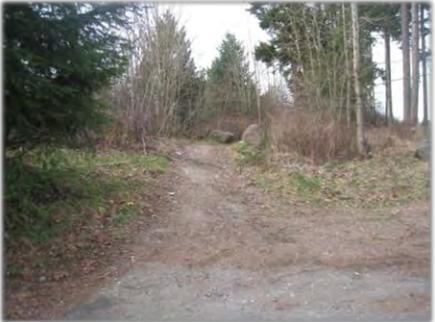
Item	Location	Description	Photo
<p>8</p>

<p>Southeast entrance to school grounds, at the western end of 112th St E.</p>	<p>This trail, starting from the western end of 112th St E, heads west into the forest along the southern boundary of school grounds. This is on Pierce County land, but has no signs marking what the intended use of the trail is or who may use the trail. According to the school's principal, uses of this trail that keep it an unsafe or uncomfortable place for students to travel include bullying, drug dealing, drug taking, and intercourse. Students on the audit said they were afraid to use this trail, and even a student living nearby the school had never been on it.</p> <p>Recommendation: The network of trails here is an ideal place to build several official trails that can act as neighborhood connectors. Making them nice, appealing trails will make them likely to be used not only by students but other members of the community, and this would likely result in a reduction of threatening behaviors.</p>

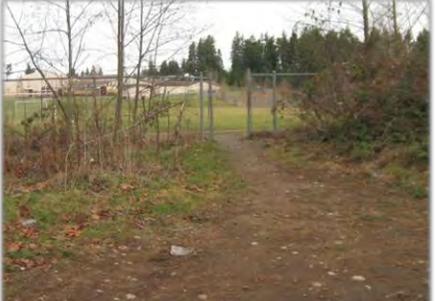
<p>South entrance to school grounds, south of the running track</p>	<p>This entrance on the south end of the school grounds appears to give a fair amount of foot traffic. The user can see that Mountain View Middle School is in the distance, yet this area feels very much beyond the school grounds, and very few students dare walk through this area because of the stories they've heard about its activities.</p> <p>Recommendation: Create a more official feeling to this entrance with signage and art. An audit participant, herself a parent, recorded in her audit notes that engaging parents to help watch this entrance and the southeast entrance during school start and end times could make it safer for more kids to walk through here.</p>

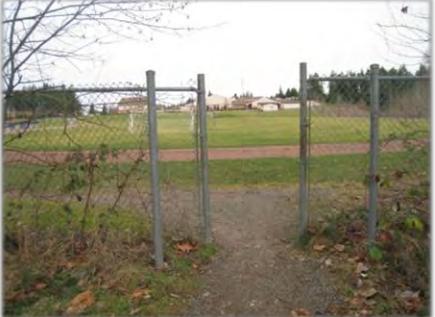
<p>South entrance to school grounds, south of the running track</p>	<p>This is a close-up view of the southern entrance, where the trail from the forest meets up with the trail through school grounds from the southeast entrance at 112th St E. There is little indication that this area is cared for.</p> <p>Recommendation: Work with school clubs, groups, and community groups to clean trash out of the area, and provide recognition of these efforts with a sign and art, similar to the Adopt-a-Highway program.</p>

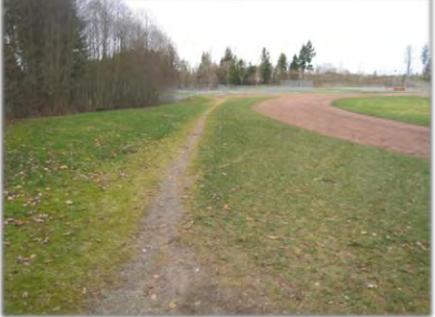
<p>11</p>

<p>Trail along south perimeter of school.</p>	<p>The trail then heads northwest toward both Mountain View Middle School and Bonney Lake High School. Students of both schools were observed during the audit to be using this trail. The narrowness of the trail indicates some use but not much by more than one person at a time.</p> <p>Recommendation: Bringing in gravel and creating a wider, hard gravel surface would indicate, and could invite, more use in general and more use by groups. It would also enable a drier walk during rainy days. Audit participants also suggested creating a gravel or paved path along the eastern side of the track that would lead directly to the school's south entrance.</p>

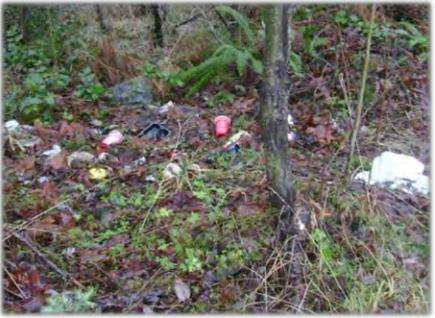
Item	Location	Description	Photo
<p>12</p> <p>

</p>	<p>On trail to the south of school grounds, near the south entrance.</p>	<p>Lots of garbage was observed on the trail and in the forest south of school grounds, further giving a sense of the area as being uncared for and discarded.</p> <p>Recommendation: Work with school clubs and members of the community to clean up the garbage on a regular basis.</p>

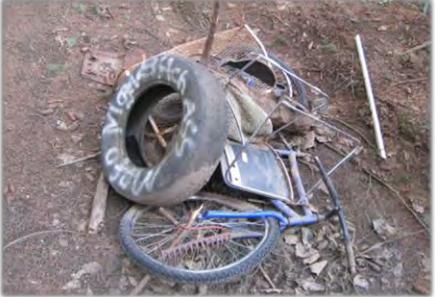
</p>	<p>On trail to the south of school grounds</p>	<p>Larger trash piles exist in places, and this one has profanities painted on it. The volume of trash would necessitate a concerted clean-up effort.</p> <p>Recommendation: Encourage members of the community to be a part of a clean up day to help haul out the larger trash. School students could be involved in the clean up too, bagging smaller trash. This could be part of a fall and spring cleaning event.</p>

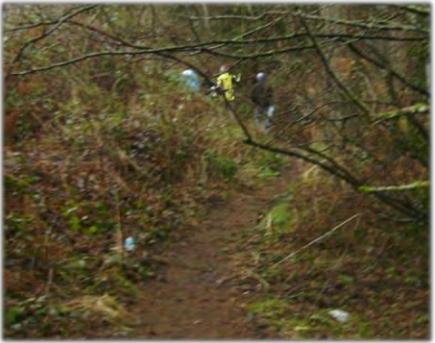
<p>14</p>	<p>Just south of the school grounds, in unofficial trail network</p>	<p>This trail leads south from the school grounds, and then can be followed east, beside a burnt- down house (next photo) , to 201st Ave Ct E.</p>

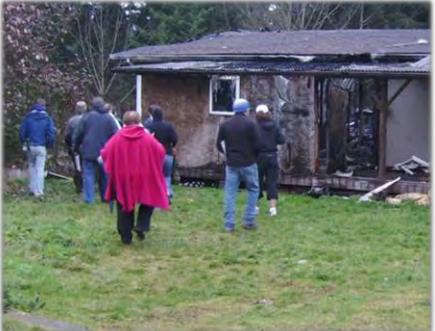
<p>15</p> <p>

</p>	<p>Northwest corner of the 201st Ave Ct E loop</p>	<p>This house appears to have burnt because of an explosion, and the fact that the grass is growing right up to the house indicates it was not a recent fire. The property is not likely in high demand, and no “for sale” sign was erected. There is an unofficial foot path just to the left of the house which connects the unofficial trail network to 201st Ave Ct E.</p> <p>Recommendation: With the edge of this property being an ideal location to place a new official community trail to provide access between this neighborhood and Mountain View Middle School, now may be the ideal time for the City to purchase a right of way along the property edge, if such an arrangement can be made.</p>

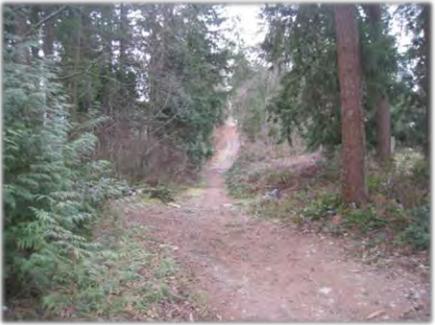
<p>South of the southwest corner of the school grounds</p>	<p>This dirt road connects 199th Ave Ct E to the north and 198th Ave E to the south. New development is planned for this area, along with paving this road and connecting the roads at the two ends. The timeline for the project has been delayed due to economic hardship faced on the part of the developer, Cascadia Project.</p> <p>Recommendation: This is a beautiful forested area, which could be treated as an asset until it is developed, through treatment of the road as a community connection. The City of Bonney Lake could work with Pierce County to develop this as a community trail.</p>

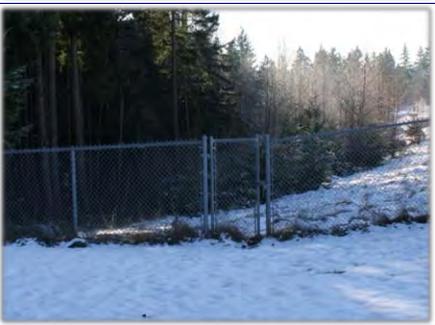
<p>Along the eastern school perimeter fence</p>	<p>The fence on the eastern side of the school prevents students from direct access to the neighborhood to the east. The alternative is to walk to the southeast school grounds entrance, and then back north up 203rd Ave E.</p> <p>Recommendation: Engage the school community and residents on the west side of 203rd Ave E to to creating a trail easement or public right of way in order to make it possible for more students to walk to school.</p>

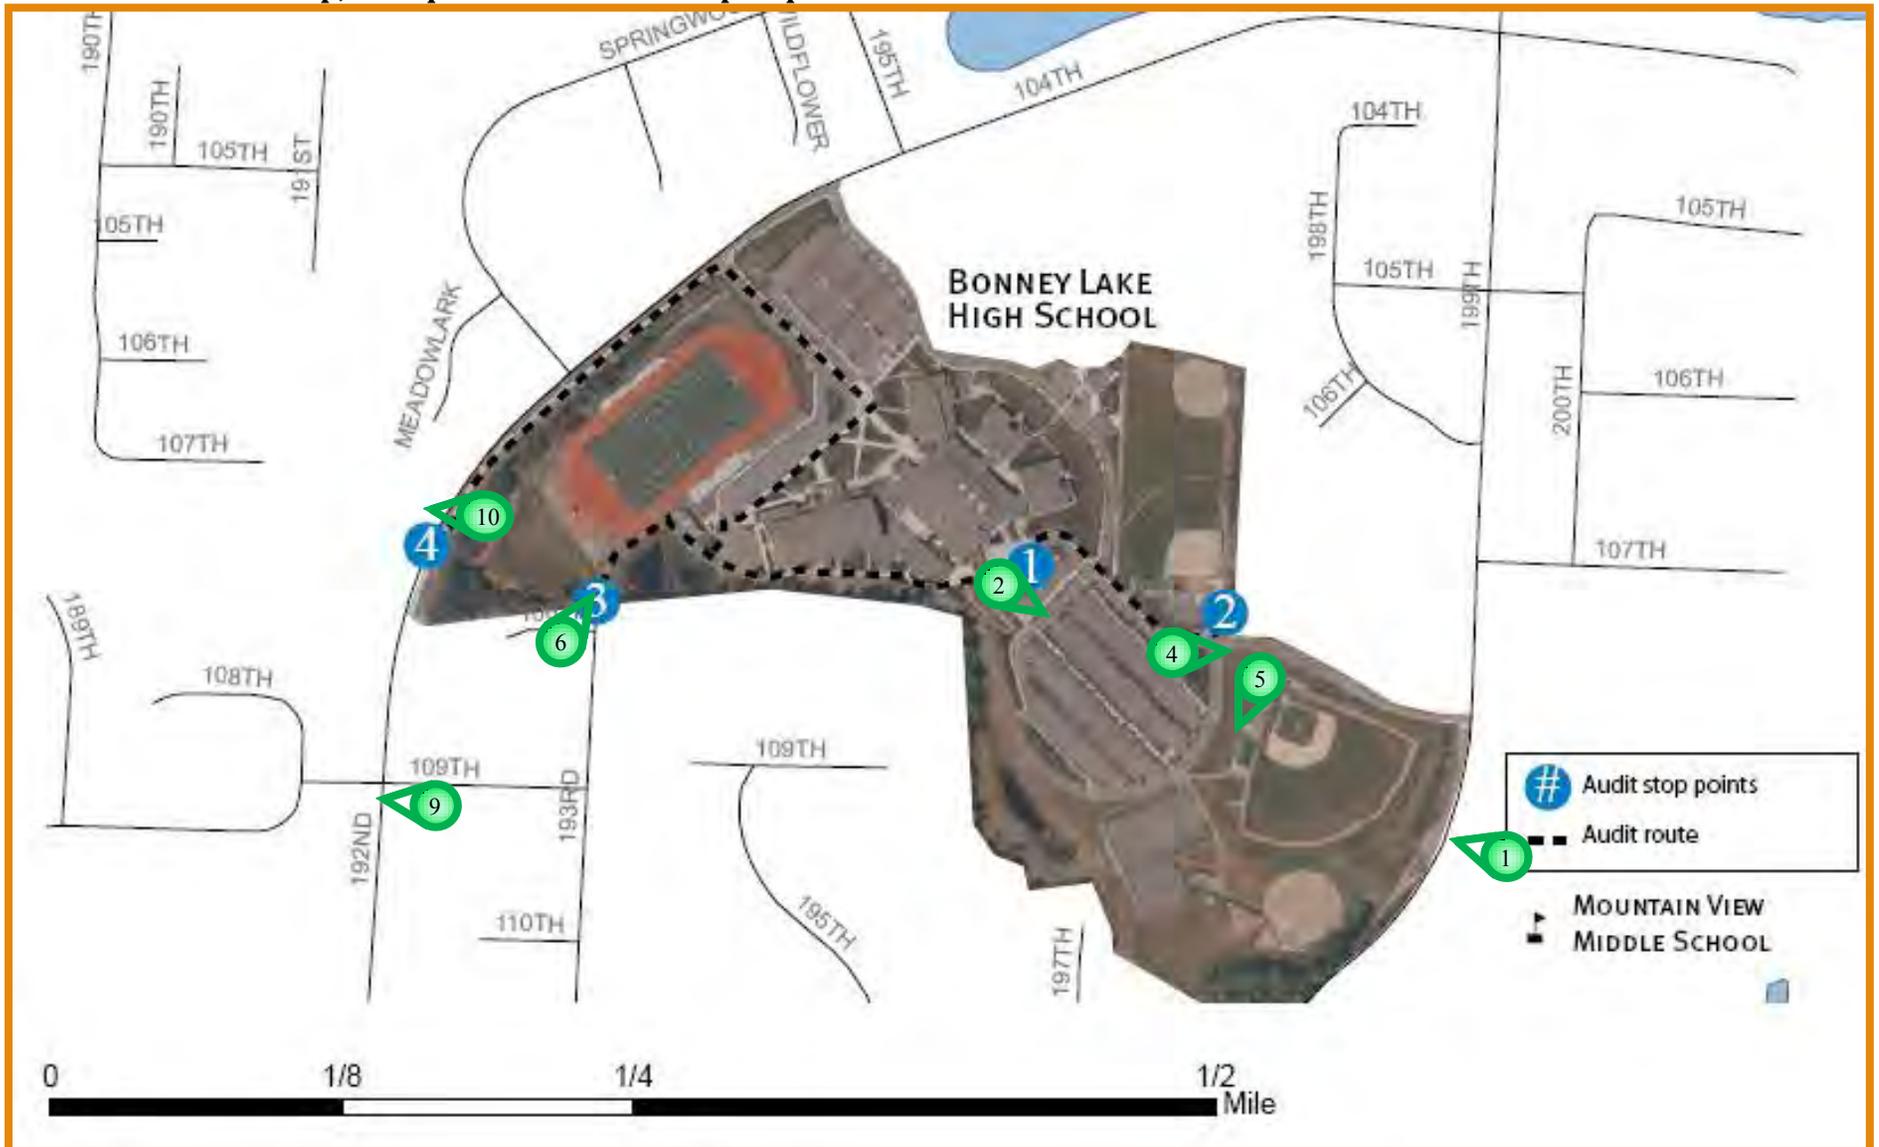
Audit Route Detail Map, with photo numbers and perspectives

3 Photo Number and Perspective. Photo 3, not shown, was taken from the same spot as photo 2; photos 7 and 8 taken from the same spot as photo 6; photos 13 and 14 taken from the same spot as photo 12.

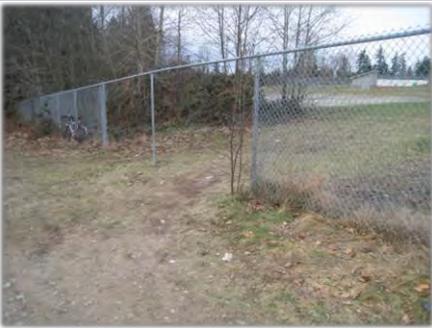
Item	Location	Description	Photo
<p>1</p> <p>📄</p> <p>☎</p>	<p>East fence of school grounds, visible from Mountain View Middle School</p>	<p>A chain link fence has been removed on eastern perimeter of school grounds, presumably by students approaching school from the dirt road that runs south to 198th Ave E.</p> <p>Recommendation: Make this an official footpath with access toward Rhododendron Park.</p>

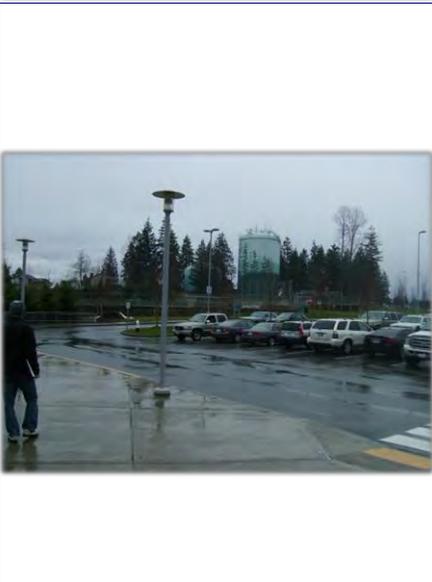
<p>2</p> <p>✳</p>	<p>Drop-off area in front of main school entrance</p>	<p>Despite signs that say “Drop-off” at the school’s front entrance, the roundabout is also used for pick-up. During these times, audit participants reported, traffic gets very backed up. Much of this is due to parents waiting in their cars before the end of school and then the pick up process when they wait for students to arrive.</p> <p>Recommendation: Add signs to discourage pick-up at the roundabout. Educate drivers, as they have at both Mountain View Middle School and at Emerald Hills Elementary, to park in the parking lot during pick-up. Require teachers to park in the furthest spots, and incentivize carpooling by providing priority parking nearest to the school for carpoolers. This would reduce traffic and increase safety around school grounds, and could be monitored by the school administration through quarterly placards. Parking further away would be designated for people who were SOV. If such an educational campaign were insufficient, consider staggering school start times by 15 minutes between Mountain View and Bonney Lake High, so that traffic can move more freely.</p>

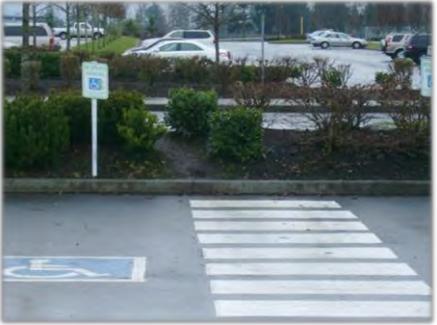
<p>Drop-off area in front of main school entrance</p>	<p>This crosswalk leads the pedestrian to a median planted with bushes, and there is no crosswalk beyond this point. This crosswalk may have been intended only for access for the handicapped parking spot. It is also the only pedestrian route toward the parking lot other than the sidewalks flanking the lot on either side.</p> <p>Recommendation: Remove the bushes on the other end of this crosswalk, and continue the crosswalk on the other side of the median toward parking lot destinations. This will give the visual indication that walking between cars in the parking lot and the school is expected, and could help with the pick-up traffic problem.</p>

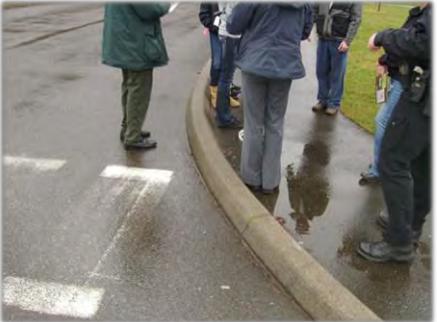
<p>On east approach to school</p>	<p>Curb in foreground of photo should have a break in it where it meets the crosswalk, and crosswalk needs to be repainted. “No Parking” signs along here have been vandalized with spray paint, or removed, lending a sense of the area being uncared for.</p> <p>Recommendation: Create curb cuts here and in sidewalk on other side of the driveway, and repaint the faded crosswalk. Replace the “No Parking” signs.</p>

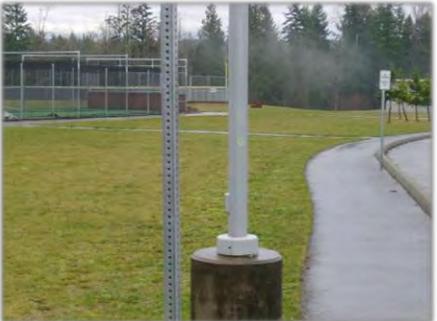
<p>Along driveway approaching the school's main entrance from the east</p>	<p>There is a lot of open grassy area on school grounds, including along pedestrian approaches. These areas serve as a general green backdrop, and some audit participants viewed the area as being underutilized.</p> <p>Recommendation: Add more visual interest to these areas. Several audit participants suggested using this space for edible landscapes. Other ideas recorded during the audit to add visual interest include a sundial and benches. This would make the experience of walking more engaging, and provide students lessons related to food and natural cycles.</p>

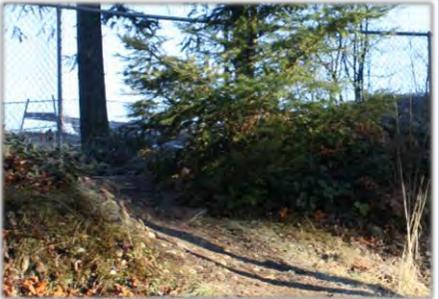
<p>North end of 193rd Ave E, just south of school grounds</p>	<p>An informal footpath was noted leading to southwest portion of school grounds, from where 193rd Ave E dead ends. The chain link fence has once again been peeled back.</p> <p>Recommendation: Make this an official entry point for pedestrians and bicyclists, with a gravel or paved path and Bonney Lake High School welcome sign. Check whether this access point would be required to be ADA compliant or if other existing ADA-compliant access points suffice.</p>

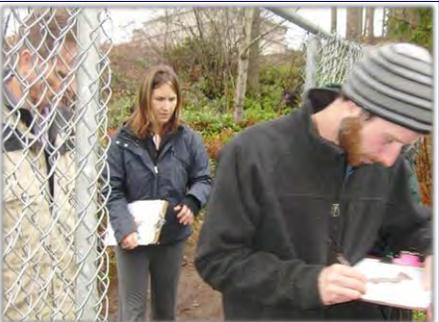
<p>7</p>	<p>North end of 193rd Ave E, just south of school grounds</p>	<p>This is a closer look at the spot where the fence has been peeled back at this unofficial southwest school grounds entrance.</p>

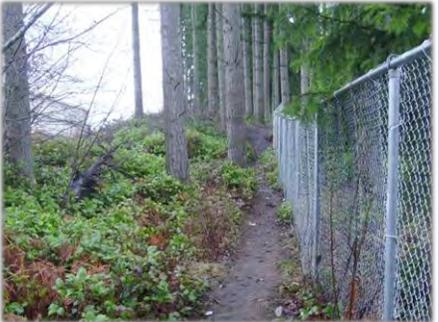
<p>Just east of the unofficial southwest entrance to the school grounds shown in the photo above</p>	<p>This footpath is an unofficial route for pedestrians to access the high school from 193rd Ave E. The police officer assigned to the high school checks on this area frequently. "420" is etched into a tree, and the officer finds students smoking marijuana here. The peeled-back chain link fence makes it clear that this is an unofficial path whose users are not supposed to be there, and this environment supports illicit activities.</p> <p>Recommendation: In addition to making this an official pedestrian and bicyclist entrance to the school grounds, audit participants suggested several other ways to create ownership of and belonging to the area, including an after-school program for science or nature observation, placing garbage and recycling bins along the trail or at the trail ends, a bench, more colorful plants and flowers, and enhancement of the retention ponds for wildlife.</p> <p>An alternate pathway from this entryway to school would be along the left (west) side of the retention pond. Boulders to demarcate a path could be used instead of a chain link fence to discourage access to (and potential danger from) the pond, in order to enhance the visual appeal of this route.</p>

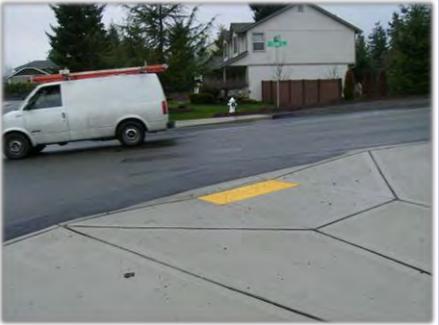
<p>Intersection of 192nd Ave E and 109th St E.</p>	<p>The crosswalk across 192nd Ave has been removed. It was apparent during the walking audit a crosswalk here would be convenient for some users, and it was unclear why it was removed.</p> <p>Recommendation: Investigate why the crosswalk was removed, and consider repainting it. In addition, paint a crosswalk and construct a median to facilitate safe crossing of 192nd Ave E toward the school's southern-most driveway.</p>

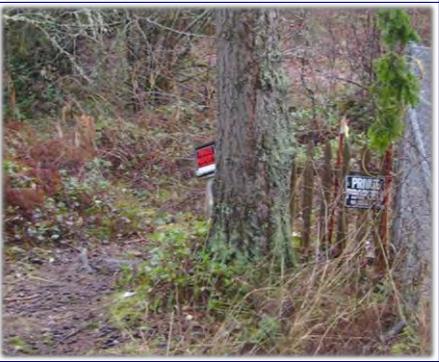
<p>Trail leading west from 192nd Ave E where 107th St E would be if it continued east to intersect with 192nd</p>	<p>Several "Private Property" signs have been posted next to this footpath that provides access from 192nd Ave E to 107th St E. Gary Leaf, the City's Community Services Director, mentioned that a road is planned to bridge this gap, when \$14 million in funding is available. In the meantime, access is at one's own risk, and requires walking through private property.</p> <p>Recommendation: Enable sanctioned access for pedestrians and bicyclists between 192nd Ave E and 107th St E by creating a gravel or paved corridor through the city-owned property adjacent to these private property signs. This would be an inexpensive access solution until the road is built.</p>

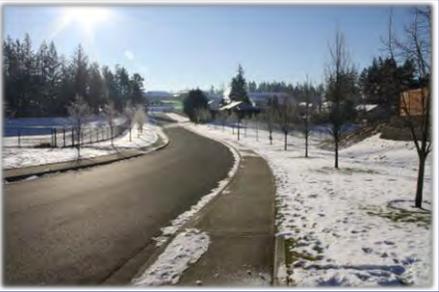
<p>12</p>

<p>Where 103rd St E dead-ends, near its intersection with 194th Ave</p>	<p>This unofficial footpath in the same neighborhood depicted in the photo above is once place where a more official trail would benefit pedestrians. It is unclear to the casual pedestrian whether travel on this trail is allowed.</p> <p>Recommendation: Check to see if this path is private property or within public right of way. Create an official pedestrian and bicyclist path bridging the street gap.</p>

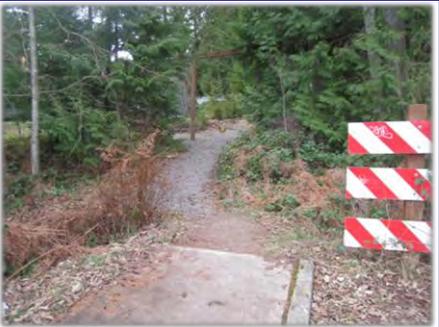
Item	Location	Description	Photo
<p data-bbox="136 115 184 159">13</p>

<p data-bbox="241 115 659 147">Same as above, slightly further west</p>	<p data-bbox="751 115 1507 302">The property owner adjacent to (or owning) this footpath has erected a swing set in the middle of the path. These are easy to get around, but indicate that the path travels through private property, whether or not this is true. Use of the swing set by residents would obviously create an awkward moment if others were to use this path.</p> <p data-bbox="751 350 1507 440">Recommendation: If this path is on public right of way, inform the neighbors of this and make a request that they place the swing set on their property.</p>

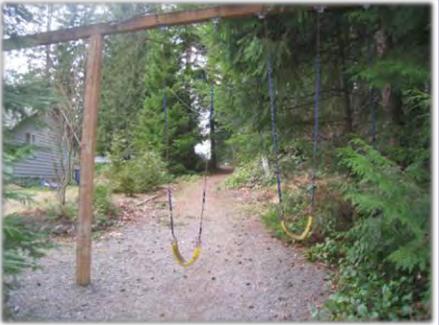
<p data-bbox="136 444 184 488">14</p>

<p data-bbox="241 444 709 542">Same as above, slightly further west, looking west toward another segment of 103rd St E</p>	<p data-bbox="751 444 1507 542">This footpath meets up with 103rd St E on the west side of the path. This cut-through, if used, can greatly decrease the distance students would have to walk to school.</p> <p data-bbox="751 591 1507 680">Recommendation: When putting in place an official trail, place a sign at either end making it clear this is a public path providing connections between the ends of 103rd St E.</p>

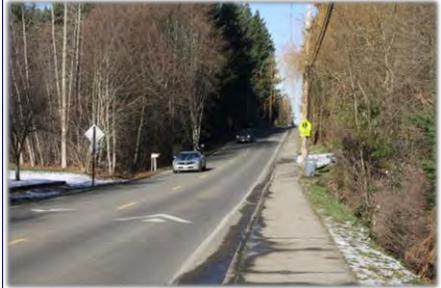
Item	Location	Description	Photo
1	Locust Ave E, near 84 th St E, looking north.	Locust Ave E has continuous sidewalks in excellent condition, and pedestrian signage near the school. This is essential on this street considering the relatively fast-moving traffic.

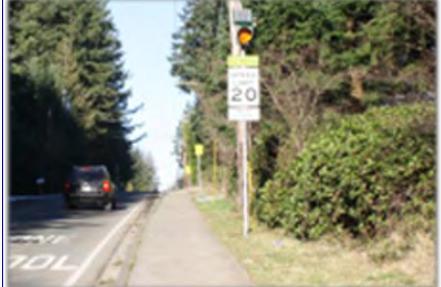
2	Looking north on Locust Ave E, just south of 80 th St E	This school zone speed limit sign and signal are well-placed, to the side of the sidewalk instead of obstructing it. The bright neon sign further down the street (barely visible in the background of this photo) is a newer, brighter sign color that is very noticeable.

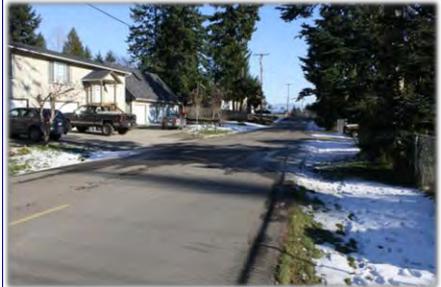
3 ☎ 📄	75 th St E and 194 th Ave E	A standard street in the vicinity of Bonney Lake Elementary has little to no shoulder, or shoulder in some areas but not others. Recommendation: Look for opportunities to create continuous gravel paths where shoulders allow but currently are only pedestrian-friendly in segments.

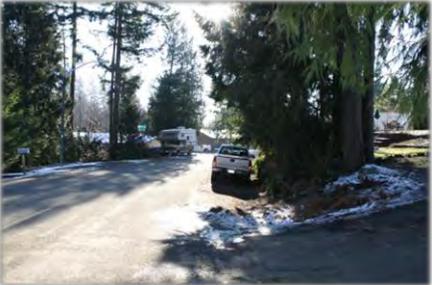
Item	Location	Description	Photo
<p>4</p>

79 th St E	<p>Even where decent shoulders exist and give room for pedestrians, this space is sometimes taken up by parked vehicles.</p> <p>Recommendation: Any new or extended gravel, asphalt or other pathway must be clearly for pedestrians through construction of a curb or other means; merely providing a shoulder can invite motorists to park there.</p>

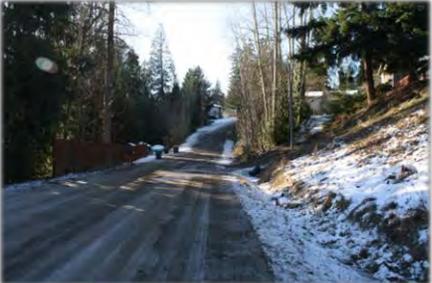
<p>5</p>

79 th St E	<p>Some narrow streets, like 79th St E shown here, are often in the shade, and this coupled with curves can make for poor visibility for pedestrians.</p> <p>Recommendation: Make this a one-way street in order to create adequate street room for pedestrians and bicyclists.</p>

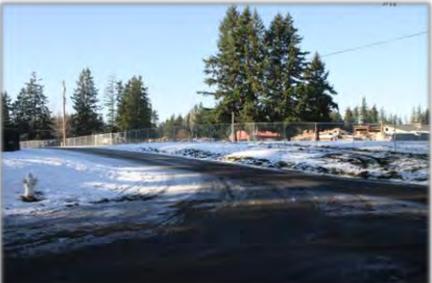
<p>6</p>

189th Avenue East and 82nd Street East	<p>The wide radius of this and many other corners do not make it necessary for drivers to slow down much or at all when turning, thus creating danger for pedestrians in the area.</p> <p>Recommendation: These intersections can be noted for reconstruction in a manner that makes for a smaller radius, thus forcing drivers to slow down more before turning.</p>

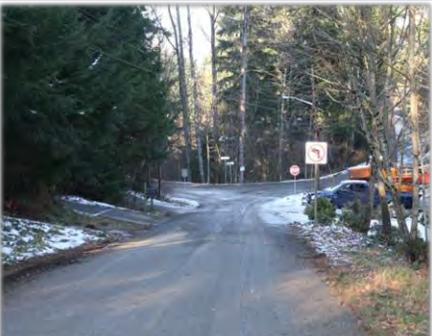
<p>7</p>

77 th St E and 182 nd Ave E	<p>Looking down 77th St E toward the one-way street encircling Lake Bonney. This one-way street is an example of a narrow street where approximately 1/3 of the street is devoted to pedestrians and bicyclists, who otherwise would have no space on the street.</p> <p>Recommendation: Consider other very narrow streets with highly limited room for pedestrians and bicyclists as good candidates for one-way treatment.</p>

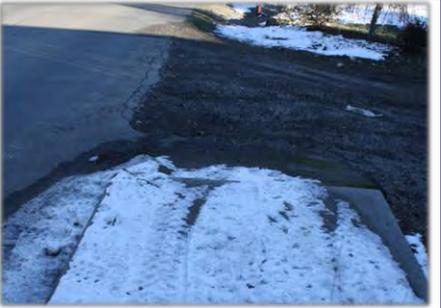
Item	Location	Description	Photo
<p>8</p>

<p>84th Ave E west of Locust Ave E</p>	<p>This is an example of discontinuous sidewalk on 84th St E.</p> <p>Recommendation: As funding permits the sidewalk should be made continuous, especially closer to the school.</p>

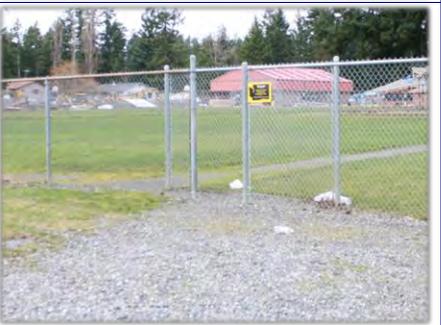
<p>9</p>	<p>Southeast school grounds entrance, near 188th Avenue East and 82nd Street East</p>	<p>This is a good access point on the southeast of the school grounds. It allows both pedestrians and bicyclists through comfortably while forcing bicyclists to dismount or slow down significantly.</p>

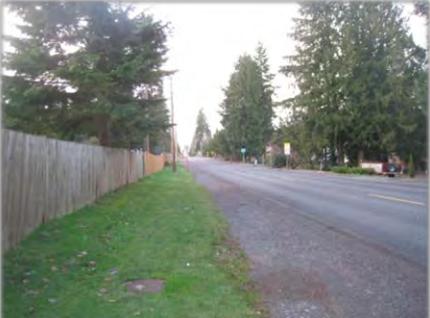
Item	Location	Description	Photo
1	South side of 120 th St E, east of 209 th Ave Ct E	Wide gravel shoulder on the south side of 120 th St E provides plenty of space for students and teachers to walk to school.

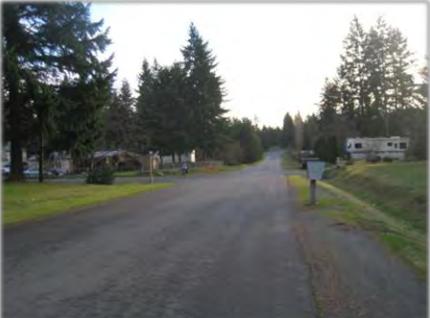
2	Looking south down 211st Ave E, near 120 th St E	Many of the residential streets in this area have wide streets and adequate shoulders to allow students and other pedestrians to travel safely.

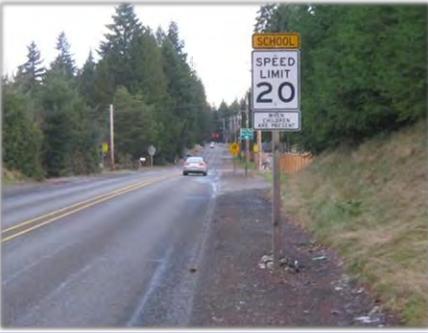
Item	Location	Description	Photo
<p>3</p>

<p>Looking east down 120th St E, just west of 209th Ave Ct E</p>	<p>This speed limit sign is in the middle of the gravel pathway used by students and other pedestrians. This sign placement communicates that this pathway is more of a shoulder than an pathway intended for pedestrians.</p> <p>Recommendation: While it is a minor obstacle, a gesture as little as moving the speed limit sign toward the street, leaving the path unobstructed, gives an improved signal that this is a walkway and not just a shoulder.</p>

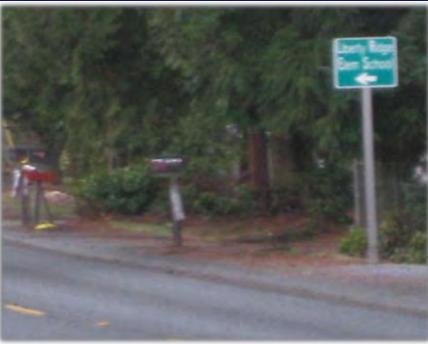
<p>5</p>	<p>Looking south down 209th Ave Ct E from a spot just south of 120th St E</p>	<p>Nice wide gravel shoulder on the east side of 209th Ave Ct E just north of school provides a good space for walkers approaching and leaving school, for most of the length of the street.</p>

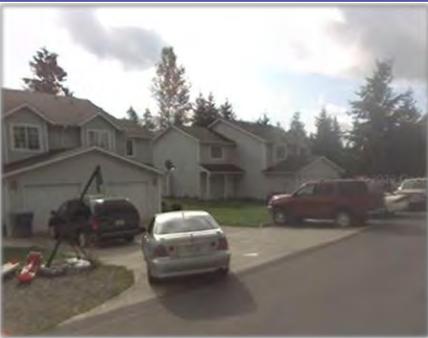
<p>6</p>

<p>209th Ave Ct E, about halfway between 120th St E and Liberty Ridge Elementary</p>	<p>This gravel shoulder/walkway is largely replaced by driveways and cars parked in those driveways close to school, making it necessary to walk in the street.</p> <p>Recommendation: Build a sidewalk or continuous path of gravel all the way down this street. In the meantime, paint a white strip demarcating the public right of way, and carry out a campaign to educate residents about where they are allowed to park.</p>

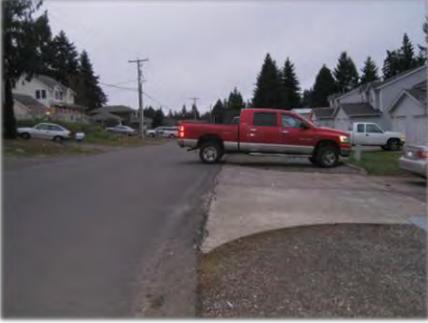
Item	Location	Description	Photo
<p>7</p>

<p>Looking north up 209th Ave Ct E from a spot just north of the school</p>	<p>Larger vehicles parked on the shoulder and in driveways force pedestrians to walk squarely in the middle of the travel lane.</p> <p>Recommendation: Build a sidewalk or continuous path of gravel all the way down this street. Before this is accomplished, paint a white strip demarcating the public right of way, and carry out a campaign to educate residents about where they are allowed to park. Education of police officers and their enforcement efforts will likely be needed at first. These actions would likely keep this area more open for pedestrians, Organized walks from the school, as part of walk-a-thons or other events, will demonstrate to students where walking is allowed.</p>

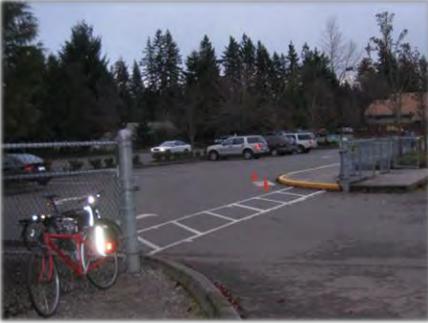
<p>8</p>

<p>North portion of school's eastern parking lot</p>	<p>The placement of the crosswalk does not match the likely walking trajectory of pedestrians taking the shoulder of 209th Ave Ct E to school. It may be that the location of the crosswalk was chosen before the fence was put in.</p> <p>Recommendation: Remove this portion of the fence, or re-stripe the crosswalk to meet up with the gravel path.</p>

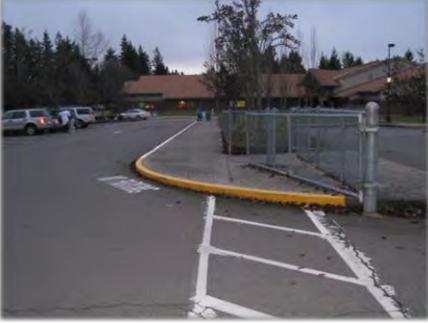
<p>9</p>

<p>North portion of school's eastern parking lot</p>	<p>While other amenities for those with physical disabilities exist and the school appears to be largely accessible to this population, more comprehensive compliance with the Americans with Disabilities Act (ADA) would include curb ramps at locations like this.</p> <p>Recommendation: Provide more comprehensive compliance with ADA regulations.</p>

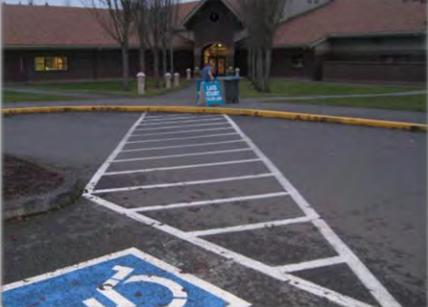
<p>10</p>

<p>In front of the school</p>	<p>This crosswalk connects the handicapped parking spot with the sidewalk fronting the school, but there is no curb ramp for someone who would use this crosswalk.</p> <p>Recommendation: ADA compliance would likely include a curb ramp, at the far end of the crosswalk shown here.</p>

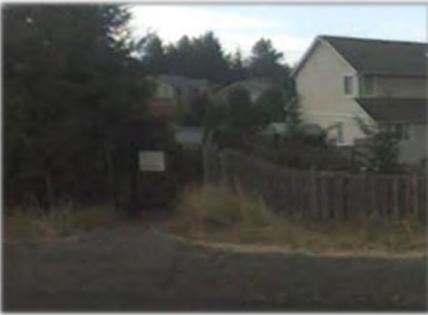
Item	Location	Description	Photo
11	Looking north from intersection of 120 th St and 209 th Ave Ct E	This gate, with the white sign, opens to a paved pathway that provides access from 120 th Street E to the portion of 209 th Ave Ct E that is just north of 120 th St E. This pathway enables a short trip of under 200 feet between 120 th St E and the segment of 209 th Ave Ct E to the north- a trip that otherwise comes to .5 miles. Such stellar accommodation for pedestrians and bicyclists was observed in a couple instances throughout Bonney Lake, and is precisely the kind of accommodation that is needed in the city, for students and members of the broader community.
