Executive Summary: Bonney Lake Bicycle and Walking Audits

Prepared for the City of Bonney Lake by the Bicycle Alliance of Washington

February 2011

Emerald Hills Elementary School Walking Audit

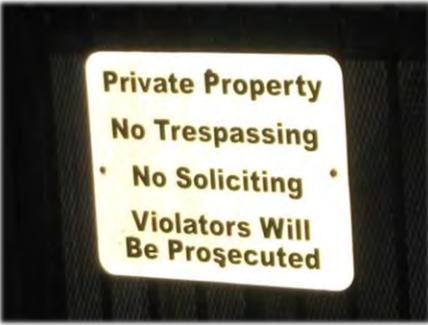
12

On north side of 120 th St, at 209 th Ave Ct E	Unfortunately for pedestrians and bicyclists, this path appears to be on private property, and the portion of 209 th Ave Ct E that it directly accesses is a private road. This sign would likely discourage most use by students living in the neighborhoods north of 120 th St E. Recommendation: Investigate whether the public is in fact not allowed on this path or on the short segment of private roadway on the other side. If not allowed currently, work with the Home Owners Association to create a trail easement or other means of allowing public access.

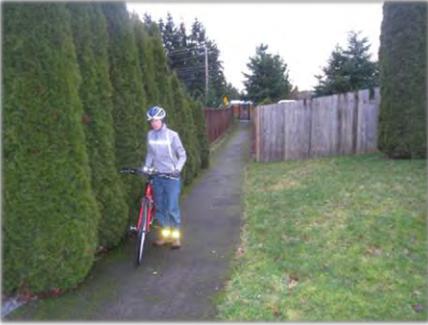
13	On pathway connecting 120 th St E and northern segment of 209 th Ave Ct E	This is the same paved pathway referred to above, here seen from the north from 209 th Ave Ct E. The path is paved and is in an ideal cut-through location for pedestrians. Recommendation: Provide more paved community cut-throughs like this in the neighborhood and throughout Bonney Lake. Include signage to provide wayfinding and that use of the path by the public is sanctioned.

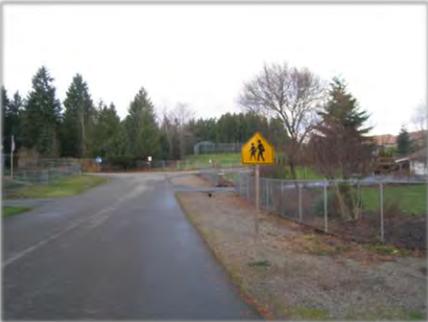
14	Looking north up 208 th Ave E from 127 th St E	A pedestrian crossing sign alerts drivers to the presence of students on streets outside the school zone, near the back entrance to the school grounds. These types of signs are very important, particularly to alert non-residents that they are likely to encounter pedestrians in areas where they may not otherwise be expected.

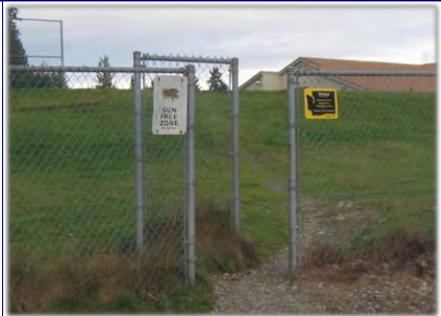
Item	Location	Description	Photo
<p data-bbox="121 115 170 159">15</p> <p data-bbox="121 175 163 201">★</p> <p data-bbox="121 212 163 238">☎</p>	<p data-bbox="212 120 443 175">Southwest entrance to school grounds</p>	<p data-bbox="491 120 1478 175">Good entrance on southwest corner of school grounds, allows through pedestrians, but forces cyclists to slow down, and does not allow through vehicles.</p> <p data-bbox="491 228 1499 315">Recommendation: Provide more gravel delineating a clear path through the grass could make this entrance more inviting while reducing the need to slosh through wet grass or mud.</p>

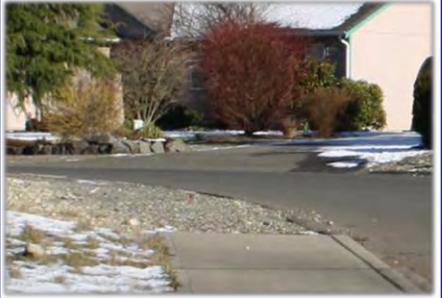
Item	Location	Description	Photo
<p>1</p> <p>☎</p> <p>📄</p>	Just west of intersection of 188 th Ave Ct E and Rhodes Lake Rd E	<p>The sidewalk ends at the intersection of Rhodes Lake Road E and 188th Ave Ct E. This is the final approach to the school and a corridor likely to get a fair amount of use from students approaching from the south and east. There is some room on the side of the road to walk, but the disappearance of the sidewalk sends the message that walking is less expected or anticipated beyond this point.</p> <p>Recommendation: Continue the sidewalk up 188th Ave Ct E to Victor Falls Elementary</p>

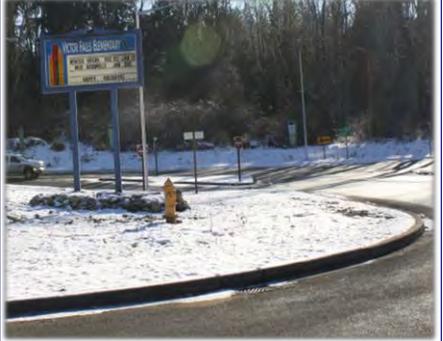
<p>3</p> <p>☎</p> <p>📄</p>	192 nd Ave E ends where it intersects with Rhodes Lk Rd E.	<p>The sidewalk on 192nd Ave E ends where it intersects with Rhodes Lake Rd E, which leaves it unclear to pedestrians what path they should follow.</p> <p>Recommendation: Create a clearer delineation of the gravel path beyond this point toward Victor Falls, or continuation of this sidewalk toward the school.</p>

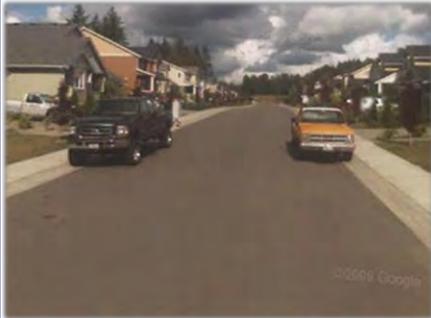
Item	Location	Description	Photo
<p>4</p>

<p>Throughout the new Falling Water development, off of Falling Water Blvd E</p>	<p>Curbs in the Falling Water development are “soft,” enabling the parking of cars well into the sidewalk. Though blockage of the sidewalk in this manner was not observed (and is not depicted in this photo), it is a common result of soft curb construction.</p> <p>Recommendation: Engage parking enforcement in observing driver behavior on these curbs to see if their parking is obstructing the sidewalk for pedestrians. Only after such a review should the City consider allowing further developments to be built with soft curbs.</p>

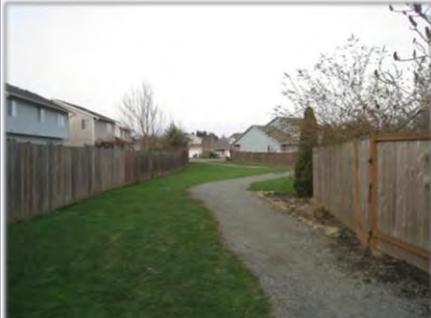
<p>6</p>

<p>Near 109th St E and 185th Ave E</p>	<p>The network of pathways within the newer development down the hill to the west of Victor Falls lays the groundwork for promoting walkability to destinations in the future, though there are currently no community destinations in the area beyond other residences.</p> <p>Recommendation: Connect the trail planned to the west of school with this trail network.</p>

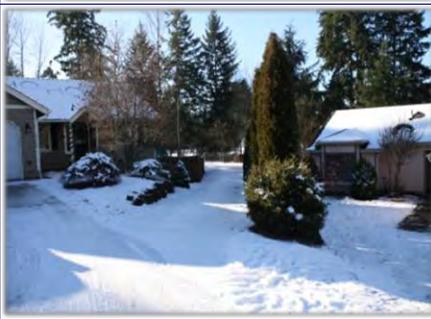
<p>7</p>

<p>Western end of 112th St Ct E</p>	<p>There is a gravel pathway leading between two houses toward Victor Falls that then leads one toward a spot where the chainlink fence surrounding the school grounds has been pulled back. This is not an official pathway to the school grounds, but appears to be used by some people.</p>

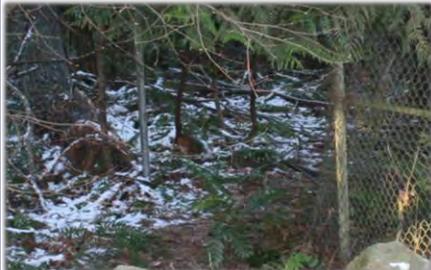
Item	Location	Description	Photo
<p>8</p>

<p>Western end of 112th St Ct E</p>	<p>There is a gap in the school grounds boundary chainlink fence, where the fence has been pulled back, enabling access from the pathway (shown above) to the school grounds.</p> <p>Recommendation: Investigate whether this access is officially allowed, and if not, take steps to provide a trail easement or public right of way. Develop the trail all the way to the school grounds and mark with appropriate wayfinding signage.</p>

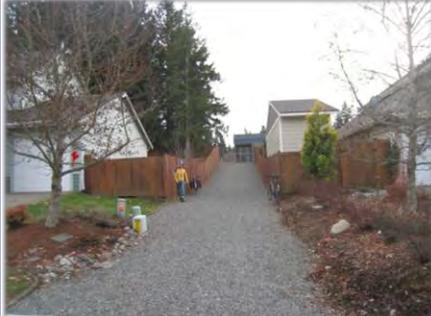
<p>9</p>

<p>Just north of the school, connecting to 111th St E</p>	<p>This pathway leading from the north directly to the school grounds is an excellent example of an officially allowed community cut-through.</p> <p>Recommendation: Promote this kind of official cut-through throughout this neighborhood and beyond. Put in place wayfinding signage to mark this as an access path to Victor Falls Elementary, in order to further promote walking to school from this neighborhood.</p>

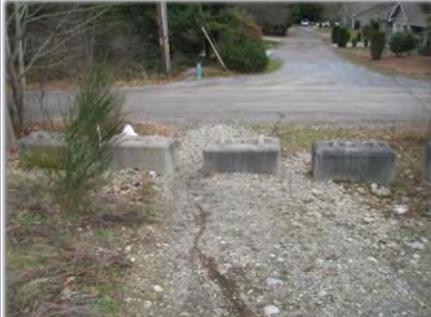
<p>10</p>

<p>Between 107th St E and 189th Ave E</p>	<p>This access point between 189th Ave E and 190th Ave E reduces a walk to school of up to 3.5 miles down to .5 miles.</p> <p>Recommendation: Improve this shortcut by making it a paved, more clearly-marked cut-through in order to make its use more inviting.</p>

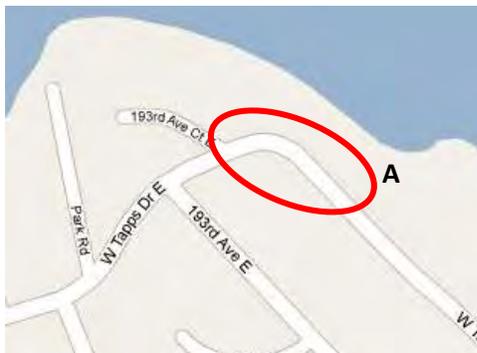
Visibility: This area had gentle rolling hills, some significant tree cover along the roadsides, and a number of sharp curves. These factors, combined with the lack of sidewalks or wide roadside paths, made visibility of non-motorized vehicles difficult.

A – This curve of W. Tapps Dr. E. is particularly difficult to see around. There is no shoulder and obstacles come up to the edge of the road. This section would be dangerous for children trying to bike from the northeast and east.

Recommendation: Add mirrors, signs, and a bikeable paved path on one side of the curve of W. Tapps Dr. E. at this location.

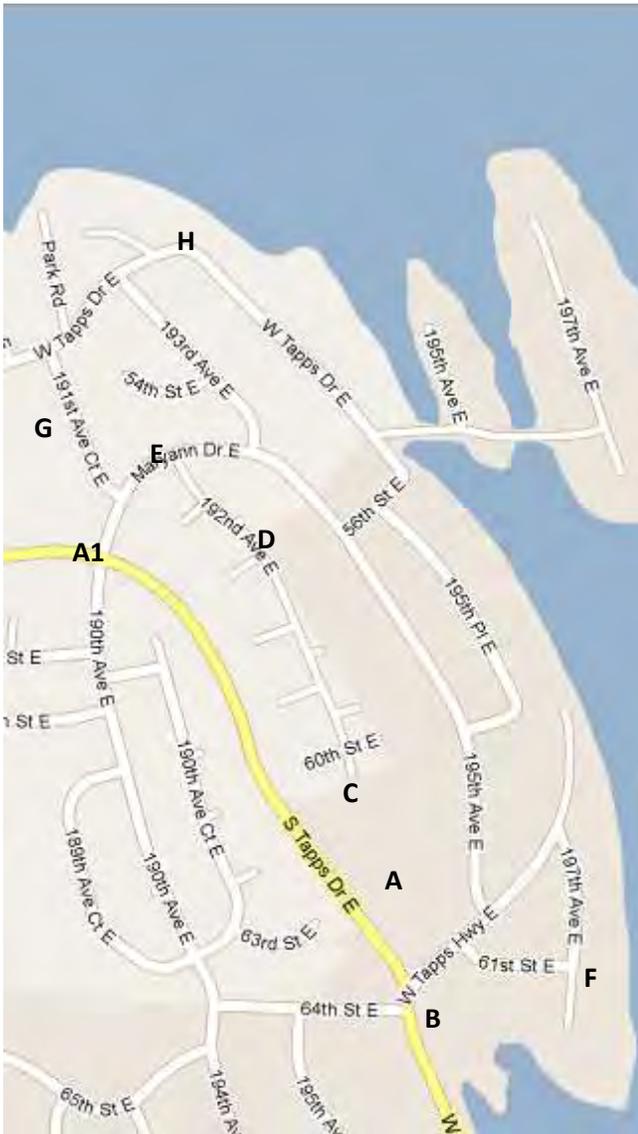
A – School grounds. A paved path goes around the field and back to the parking lot. It looks like it could go to the entrance on the other side of the field, but it doesn't. Sidewalks available, but lack of curb ramps makes bikeability difficult.

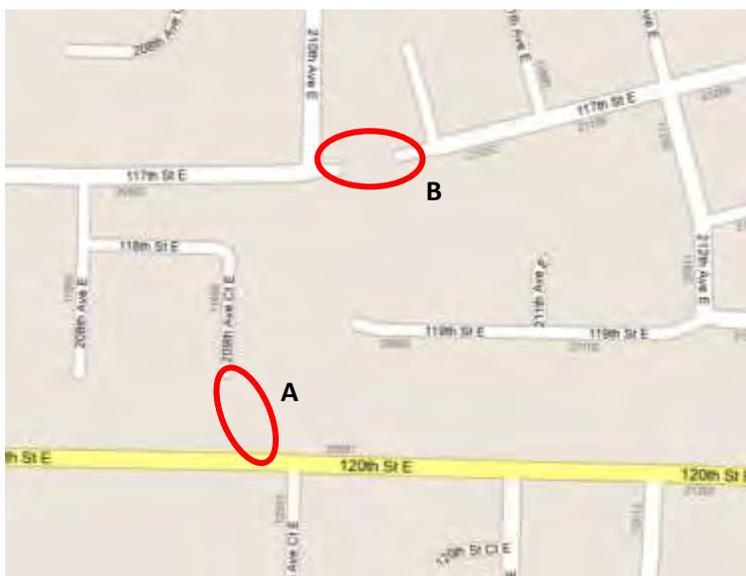
A – A bikeable, paved access path from 209th Ave. Ct. E. let out very near the crosswalk on 120th St. E., directly across from the main access to the school (see LRE images 0045 and 0046). This path was gated and had a sign indicating it was private property.

Recommendation: Obtain permission for all children to use this pass-through as an access to Liberty Ridge from northern neighborhoods, if it is not already available for that use. Also recommend educating parents in northern neighborhoods about this access point.

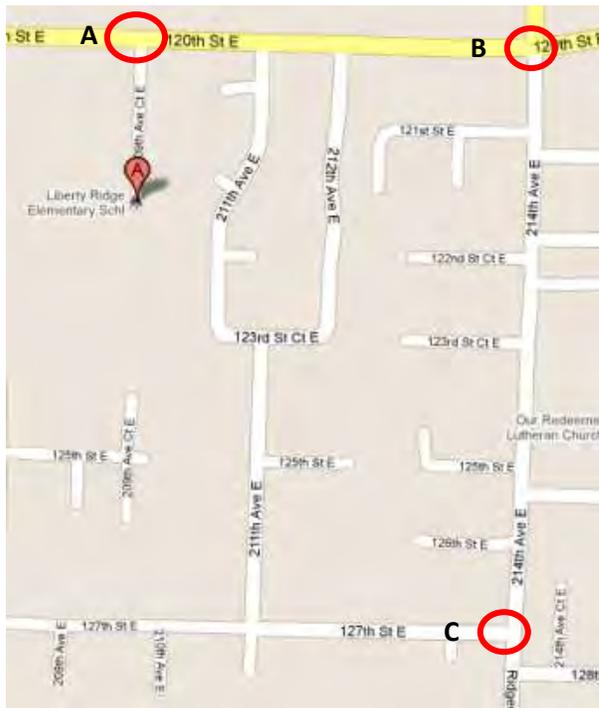
A – Intersection with crosswalk.

B – Intersection of 120th St. E. and 214th Ave E.

Recommendation: Add crosswalk facilities at the intersection of 214th Ave E. and 120th St. E. and at the intersection of 127th St. E. and 214th Ave E. Add user-triggered crosswalk lights, designated bicycle facility signage, and lowering speed limit on this road during school hours.

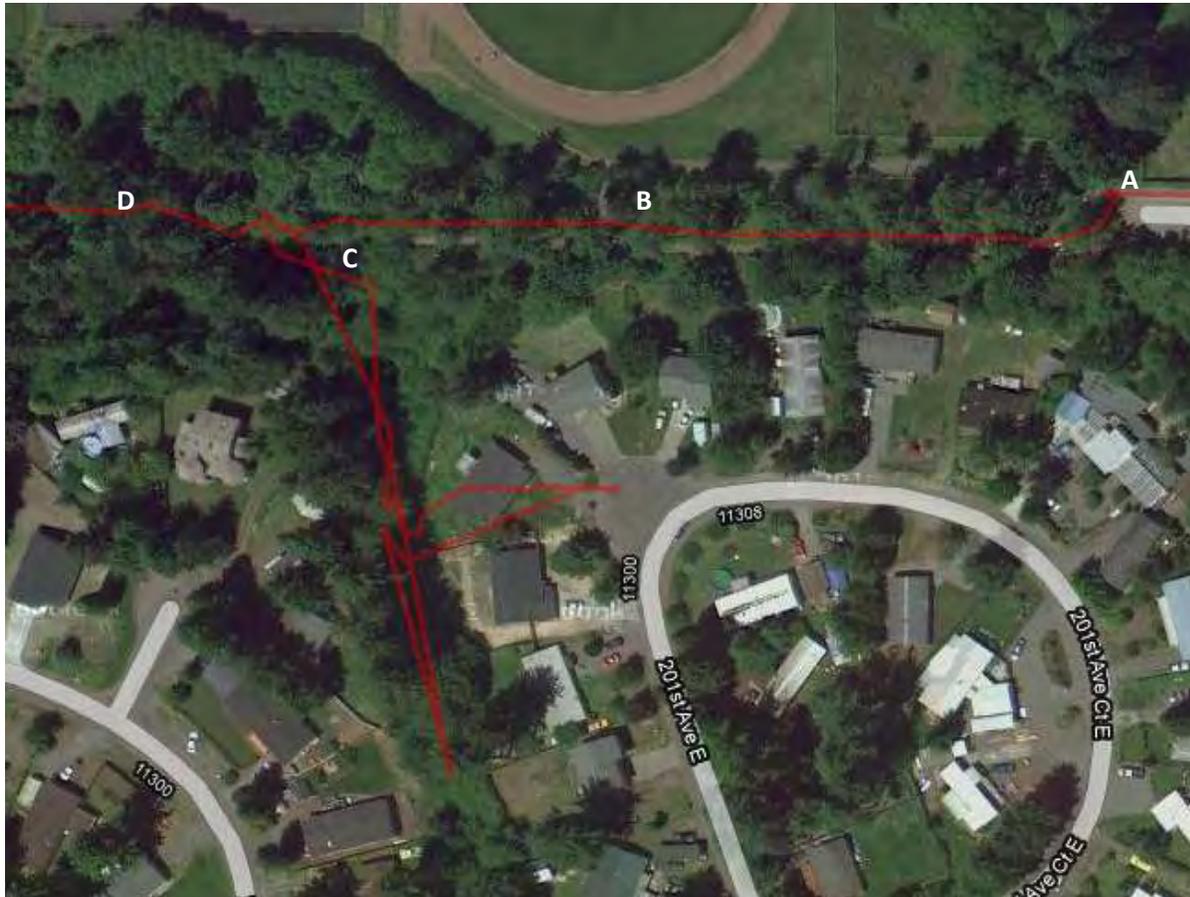
Additionally, access to Mountain View Middle School is available from 112th St. E., 198th Ave. E., and 201st Ave. E. on dirt trails (see MVMS images 0042 – 0057). This network of trails is not easily accessible by bicycle. It cuts through private property to access 198th Ave. E. and 201st Ave. E. Auditors observed significant amounts of trash (MVMS images 0049, 0051, 0052) on the trails. The trails are used by students for illicit activities and currently represent a potential hazard to legitimate users.

A – Access to school directly from 112th St. E. (MVMS image 0043).

B – Access to school farther along the path (MVMS images 0045 [view from 112th St. E.], 0046 [view from path towards Mountain View Middle School], and 0047).

Recommendation: Pave access from 112th St. E. to both available breaks in the fence, organize students to clean up and maintain the trails, and add lighting at the southern entrances.

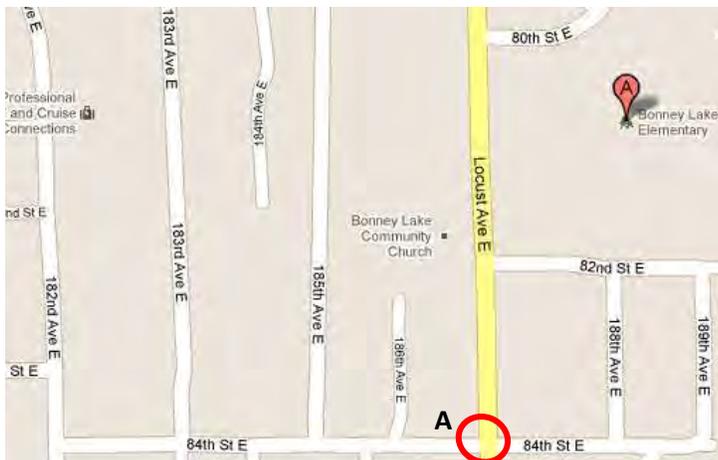
A – Intersection of 84th St. E. and Locust Ave E. As there was a slight hill just before this crosswalk, drivers tended to be traveling fairly rapidly at this intersection.

Recommendation: As discussed above, improve crosswalk here to facilitate bicycle access from the west.

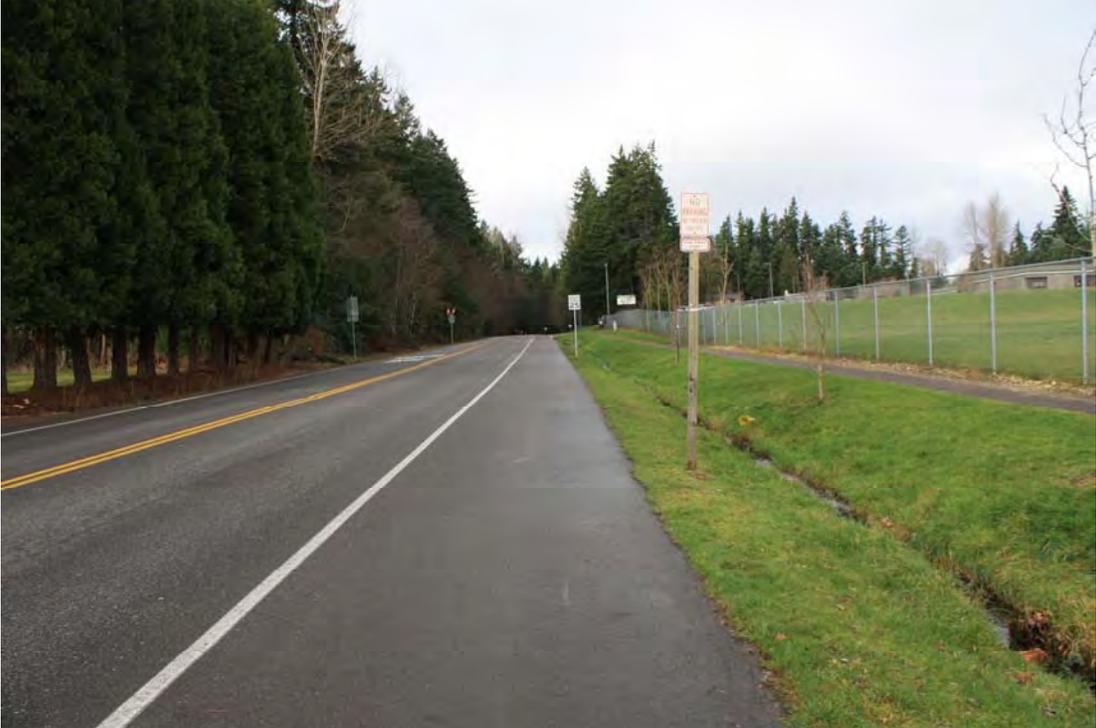
EHE_0021

Along the school property parallel to S. Tapps Dr. E., there is a good wide shoulder and good signage (EHE image 0021). However, the speed limit increases to 35 mph and the shoulder goes away immediately after the school property ends. This road is clearly not a practical solution for getting kids to school (EHE images 0022 and 0023) as built; see recommendations above.

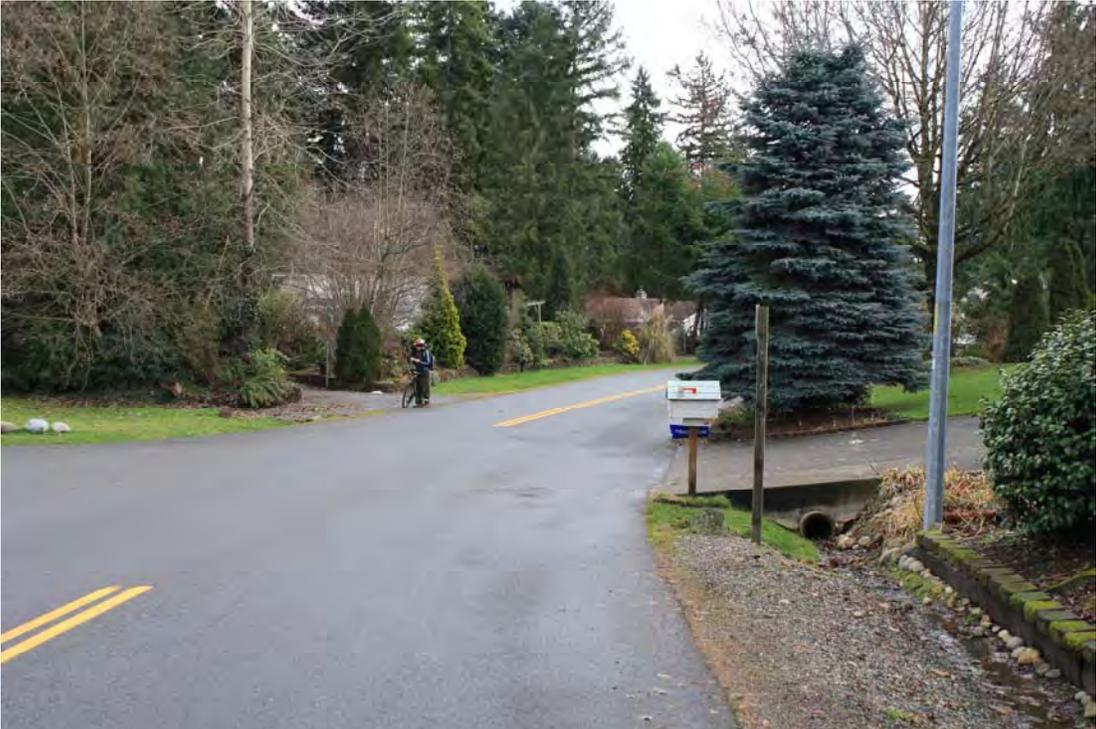
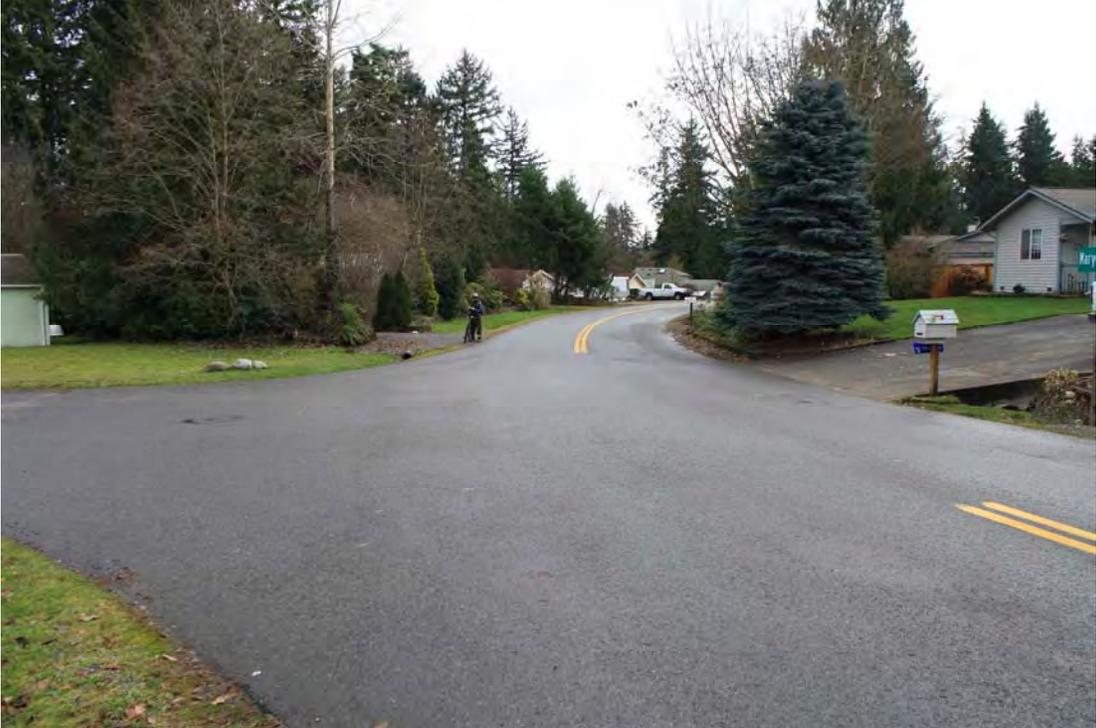
EHE_0024

A tree sticks out at the intersection of 193rd Ave E and Maryann Dr. E, on the south side of the road, and limits visibility unnecessarily (EHE images 0024 – 0025).

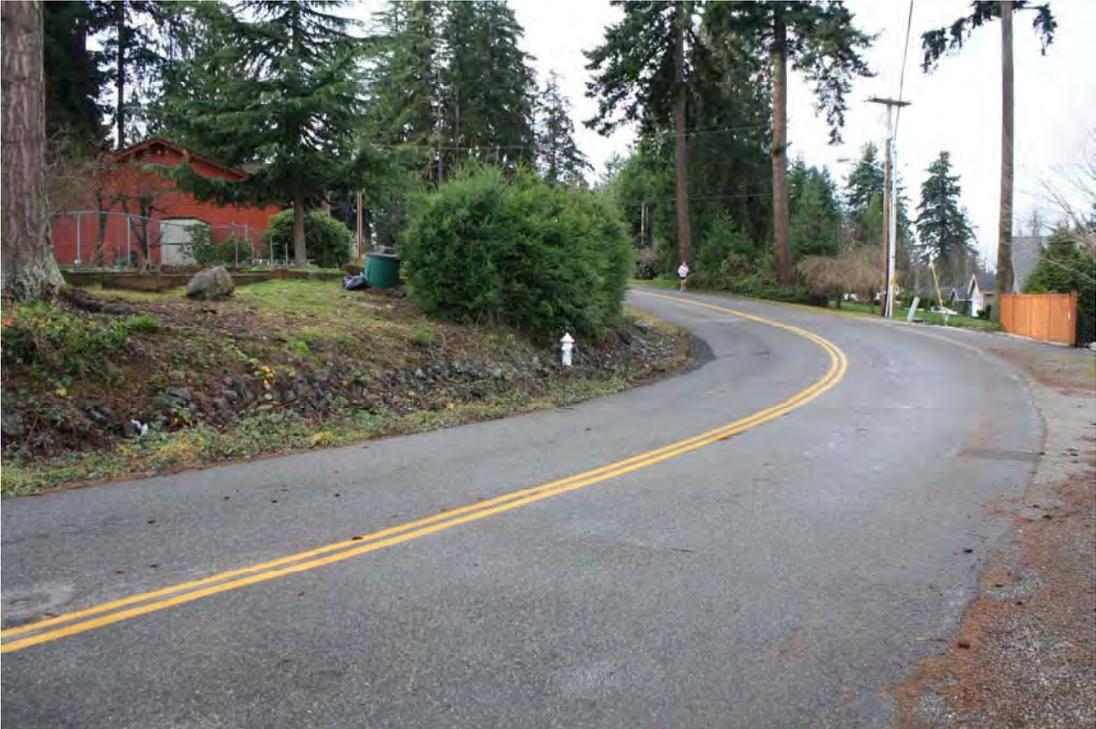
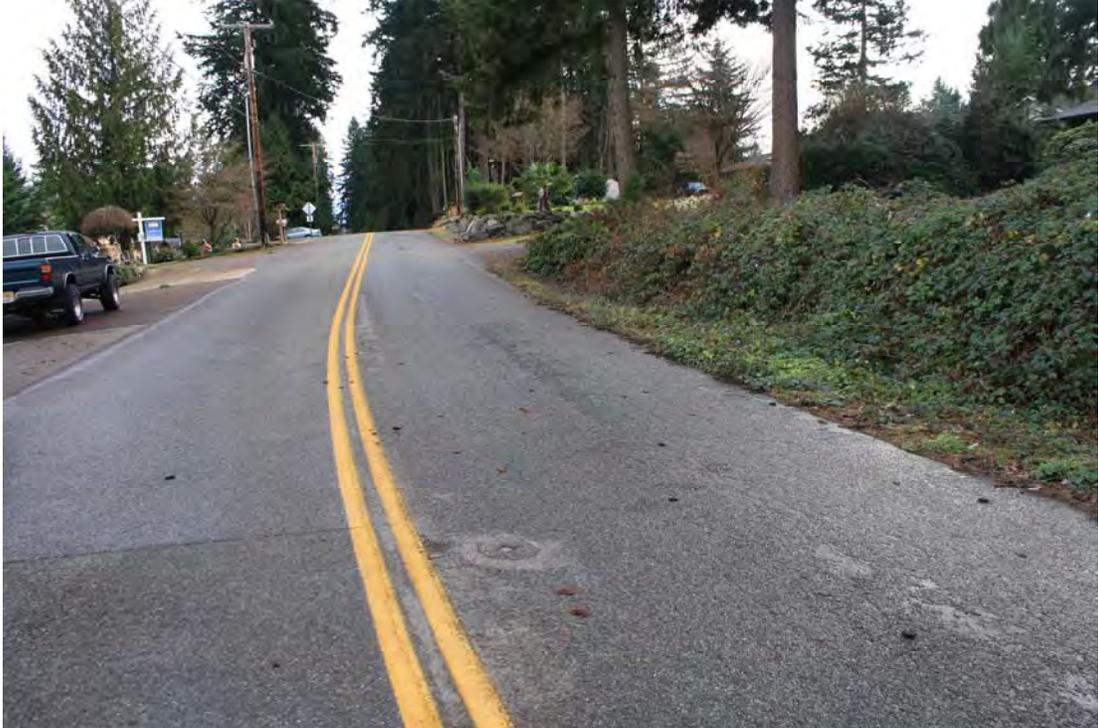
EHE_0026

H – This was an almost blind curve; very poor visibility, no shoulder, and nowhere to get off the road (EHE images 0026 and 0027).

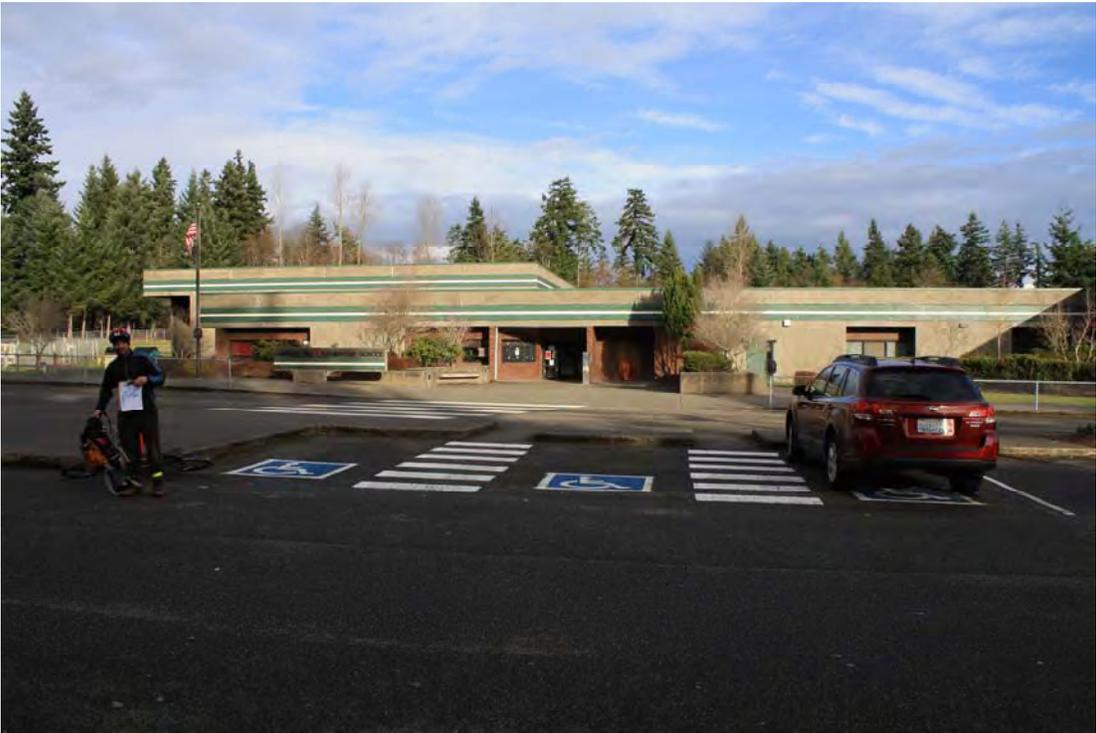
EHE_0033

Few curb ramps were observed on the sidewalks within the school. Lack of curb ramps increases the difficulty of transitioning from road to sidewalk by bike (image 0033).

Recommendation: Assess curb ramps on school grounds and modify to improve accessibility.
